ARC FLASH TESTING OF TYPICAL 480-V UTILITY EQUIPMENT

Abstract – A test program was completed to measure arc flash incident energy from actual 480-V utility equipment to determine the most appropriate flame resistant clothing for utility workers. The equipment tested included self-contained and CT-rated meters, padmounted transformer secondary cubicles, power panels, and network protectors. Testing was performed to determine the sustainability of low voltage arcs in actual utility equipment, the most appropriate calculation method to predict the measured incident energy, and to identify any key variables that would effect both duration and heat from this type of equipment.

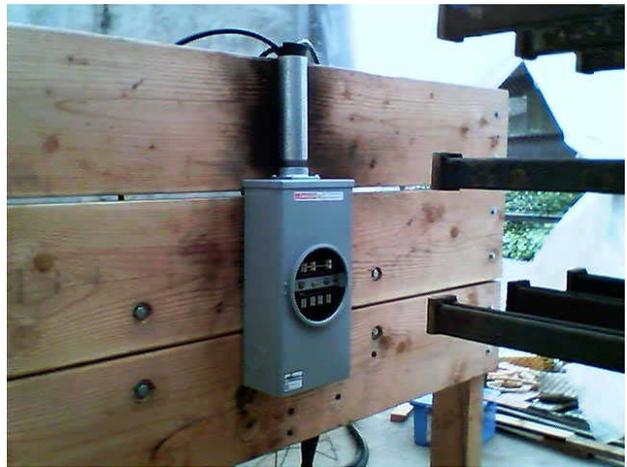
Standard seven jaw (type 16S) self-contained three-phase 480-V meter bases were mounted to a back board as shown in Fig. 1. Incident energy was measured by nine copper calorimeters on stands spaced 8" apart and positioned 18" away from the meter jaw, as shown in Fig. 2. Calorimeters were built and calibrated according to ASTM specifications [7, 8].

Fig. 1. Self-contained meter test setup

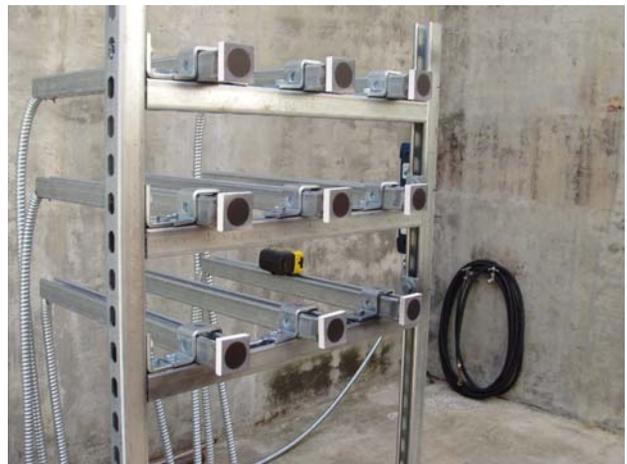
Fig. 2. Calorimeter array

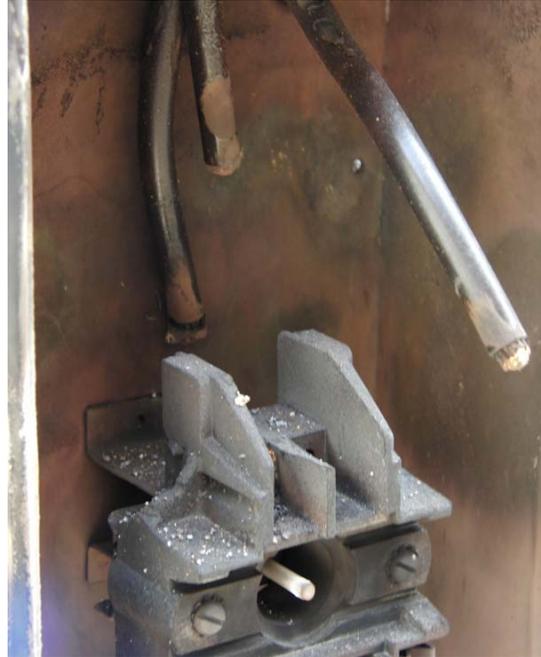
Fig. 4. Meter base after a fault

Test data is shown in Tables 1 through Table 4. As shown in Fig. 4, the majority of the events ended when all of the copper from the line side meter jaws had vaporized along with the 1/0 copper lugs that attached the power source to the meter base.

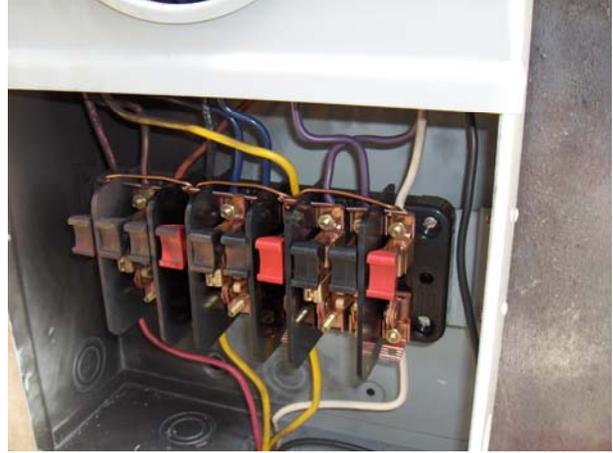
measured by nine copper calorimeters mounted on stands spaced 8" apart and positioned 18" away from the meter jaw, Arcing was initiated at two different locations in the meter enclosure. The meter base was shorted with 22-AWG wire for one set of tests as shown in Fig. 9, and then the switch block was shorted with 14-AWG wire as shown in Fig. 10.

Fig. 10. Shorting wires in the switch block

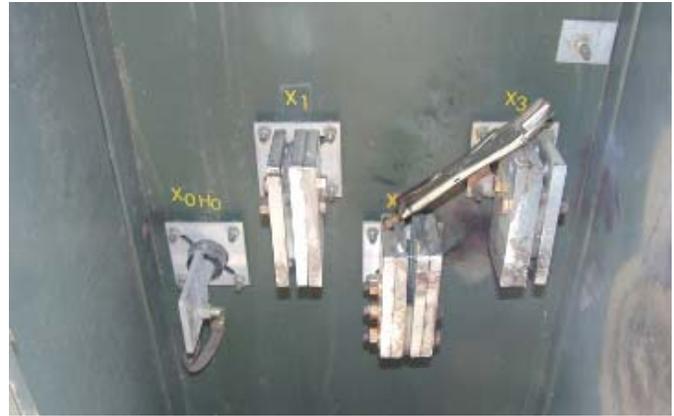
Fig. 14 shows a typical fault test initiated with a pair of vice grips laid across phases. The phase spacing in this configuration is approximately 2.75 in. This phase gap was progressively shortened by adding plates to see if tighter spacing would cause the arc to sustain.

Fig. 14. Vice grip initiated test setup

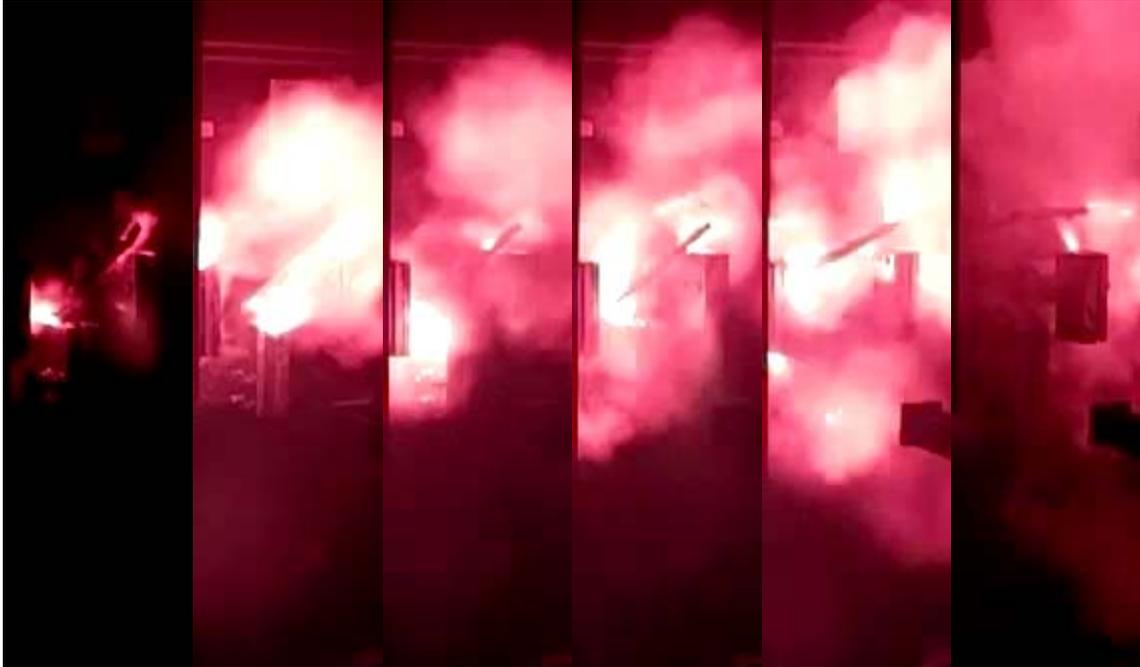
Event 288

Fig. 15 shows a progression of high-speed video frames taken. The event lasted less than two cycles as shown in Fig. 16. Note that the event progressed from a line-to-line fault to a three-phase fault in less than a quarter cycle.

Fig. 15. 1200-fps video snapshots through an infrared-passing filter

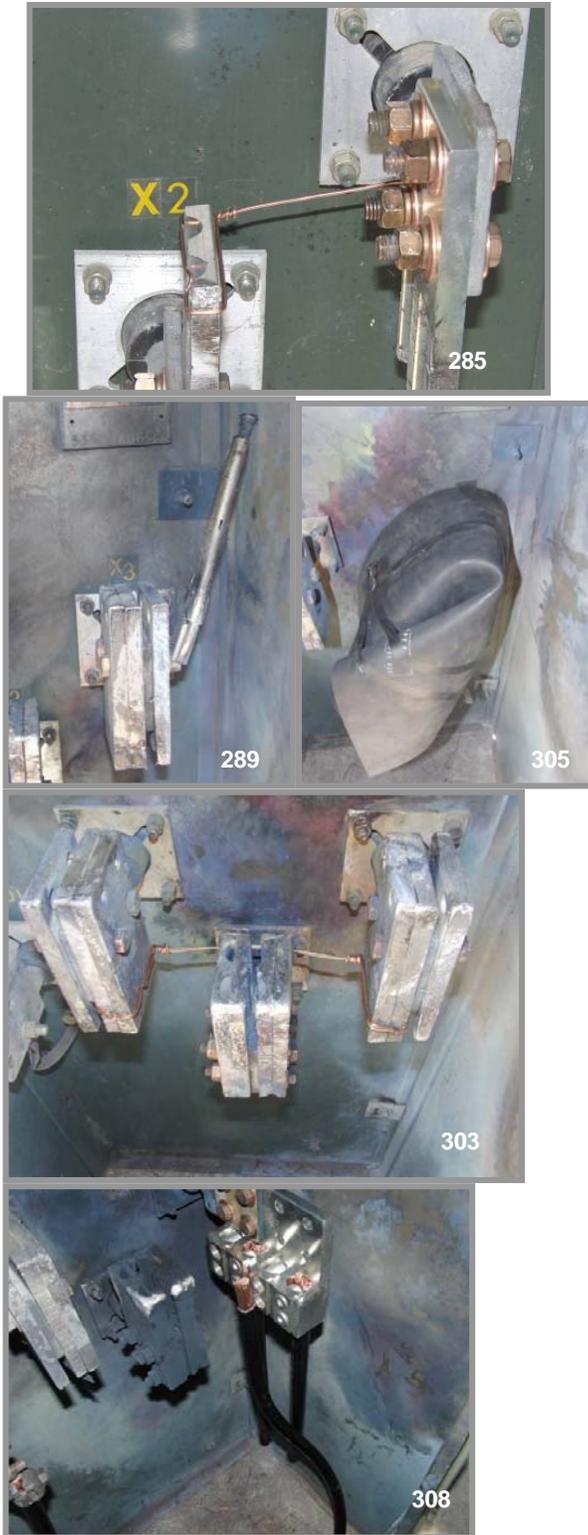
Fig. 17 shows several fault initiations that were tested. Both phase-to-ground and phase-to-phase faults were attempted. Some common observations include:

Fig. 17. Fault variations tried along with current waveforms

end. See event 308 in Fig. 17 for an example where the conductor is solidly grounded to the neutral bushing and then touched to the connector. In this case, the fault lasts longer than the fuse wire or wrench tests, but it still clears quickly.

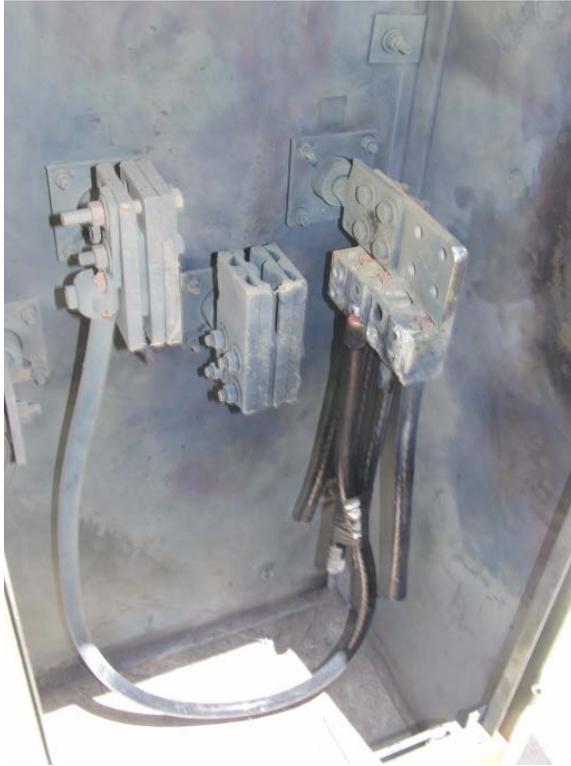
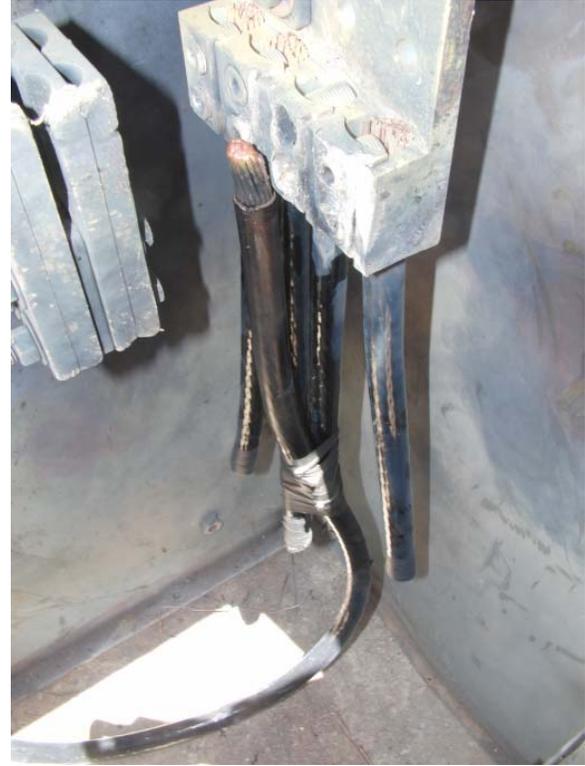
Event 310

Fig. 18 shows a test for a phase-to-phase connection. This test was made more severe by taping the incoming cable to adjacent conductor stubs to prevent cable movement. This event cleared in less than 12 cycles. From the damage

Fig. 18. Cable jumpering phase-to-phase with the fault point taped and wire tied on the right

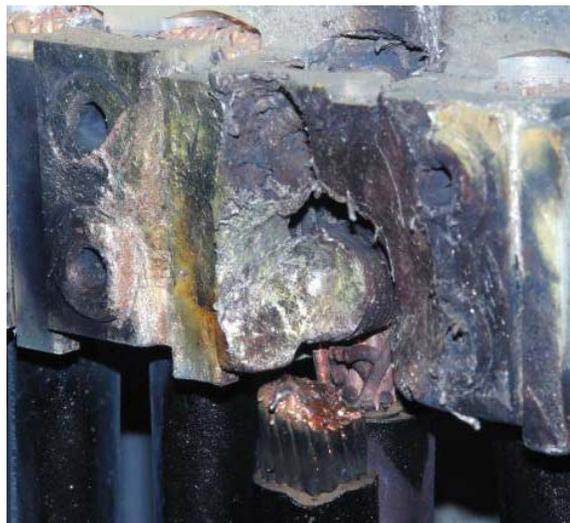
observed after the event (Fig. 19), we see that the cable and aluminum alloy connector both burned away, apparently until the gap was large enough for the arc to self clear. As this was the most severe event found so far, this fault scenario was tried at other spacings and fault currents. Fig. 20 shows an example tested at a spacing of less than two inches. Faults still cleared within 12 cycles. Fig. 21 shows waveforms for some of the longer-duration events.

Fig. 19. Results after event 310

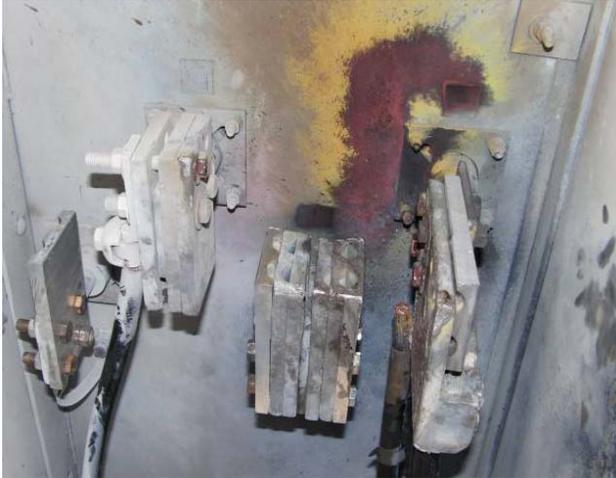
Fig. 20. Event 317: two-inch gap between phases

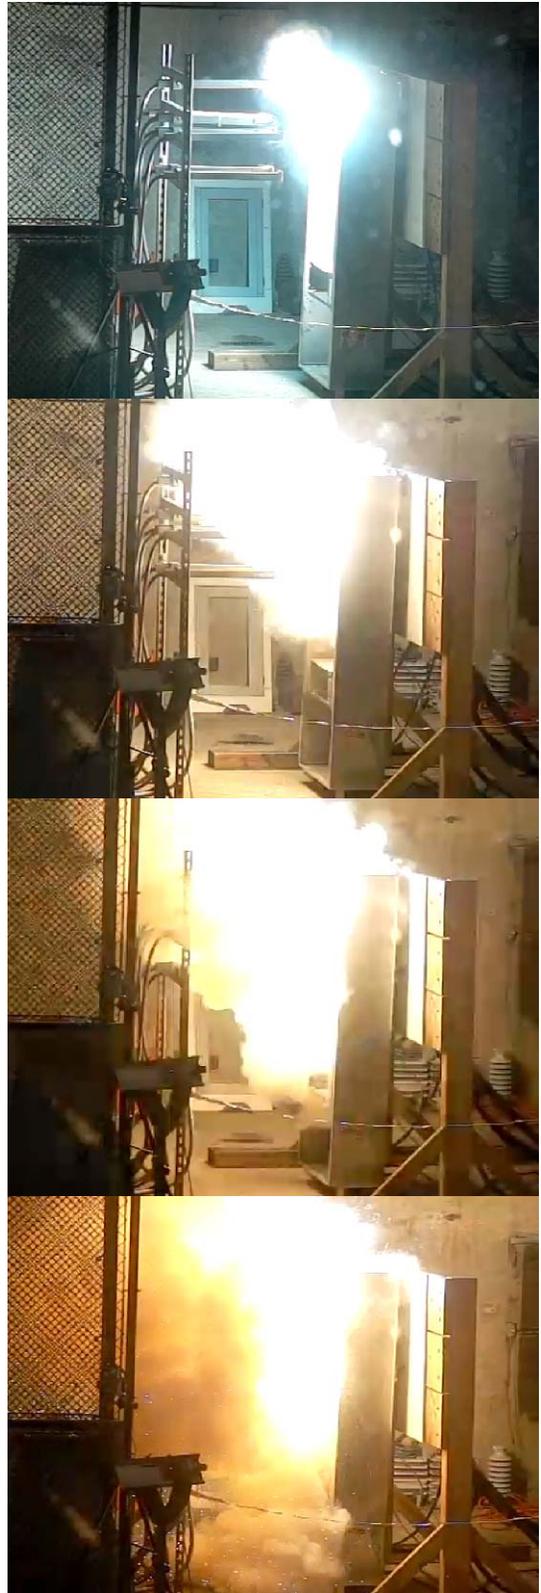
Fig. 28 shows damage after the event, and Fig. 30 shows high-speed video frames from this event.

Fig. 30. 250-A power panel for test 232

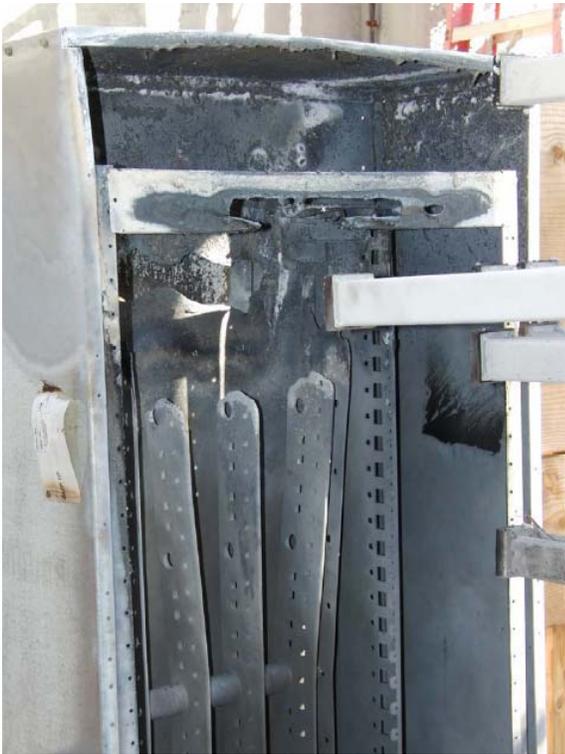
Fig. 31 shows an identical panel after another test. This fault heavily damaged the calorimeter array, and the panel enclosure suffered significant damage. This event did not self clear. The fault was cleared by laboratory protection just prior to two seconds. Incident energies likely exceeded 140 cal/cm². Fig. 32 summarizes the measurements during this test. Fig. 33 shows high-speed video frames from this event. This fault had almost three times the arc energy in the fault as test 232. The event showed no signs of self clearing as the smaller panels and likely would have continued until all the bus had been consumed.

Fig. 31. 250-A panel after test 233

The amount of bus bar burned in the panel in test 233 matched closely with the Stanback equation. The panel had 3.25 × 0.25 inch aluminum bus bar, and approximately eight inches was burned from each phase. Based on these measurements, the bus volume consumed was:

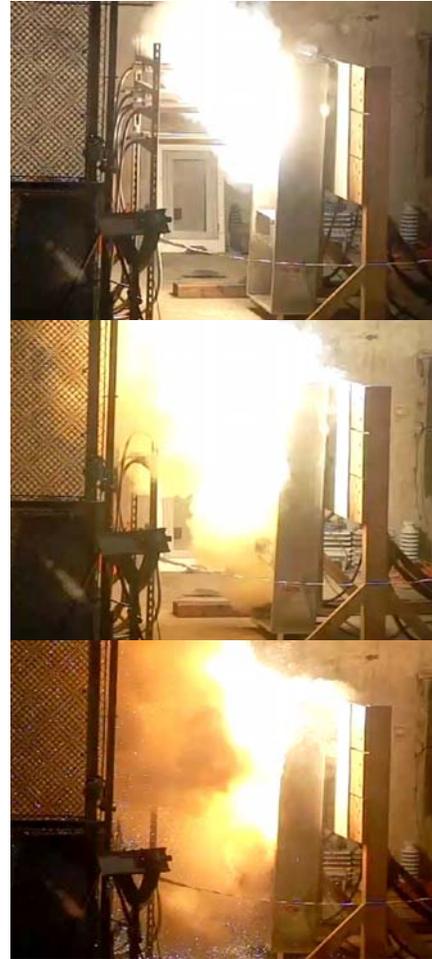
Fig. 33. 230-A panel test 233

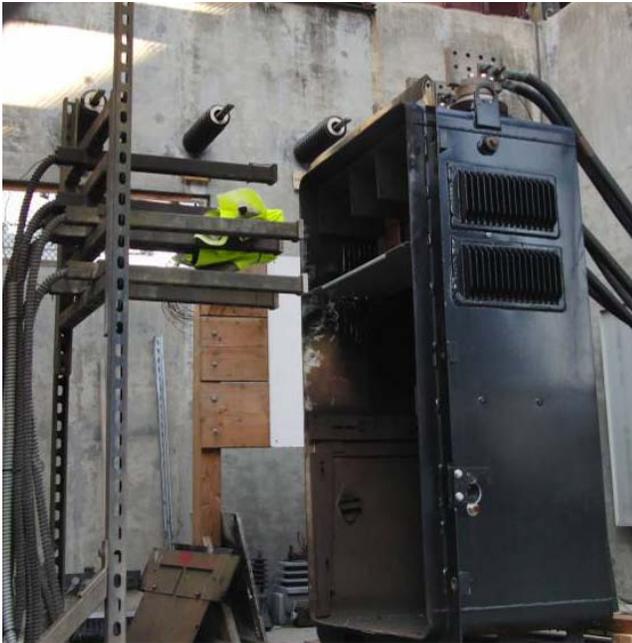
Fig. 34 shows the network protector used during tests. The internal operating mechanisms have been stripped from the unit. The unit is energized from the top, which is the network side of the unit. A common work procedure is removing the fuses on the network feed. Bus bars from the top were included in the box as shown in Fig. 35. The unit is fed by a 480-V source that's capable of supplying a bolted fault current of 52 kA.

Fig. 34. Network Protector Test Setup

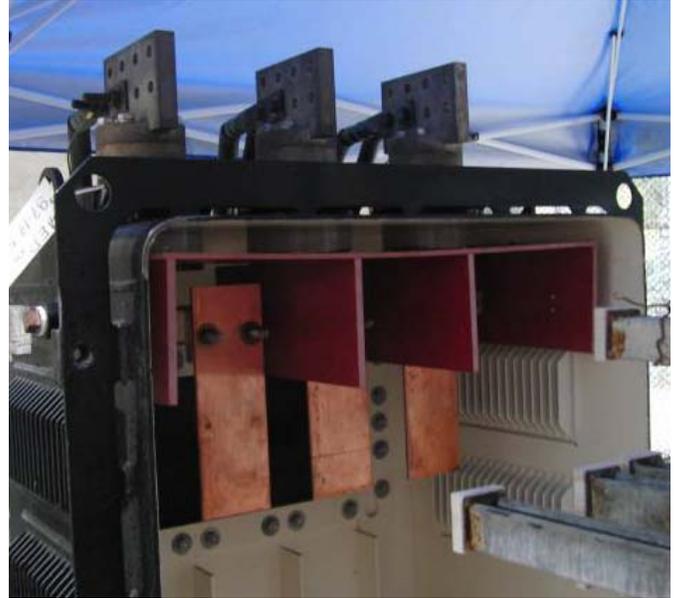
Fig. 35. Initial internal electrode configurations

Fault events were normally initiated with a 12-AWG copper wire connected between bus bars. Vice grips were also used to initiate faults. With the initial wide-open box configuration, faults self extinguished. Fig. 36 shows an example of a fault initiated by a set of vice grips that cleared in one half cycle (see Fig. 37). With the wide open spacings, arcs self extinguish. The magnetic forces push the arc towards the bottom of the enclosure, and the arc balloons out in the process, reaching a length where the fault cannot sustain.

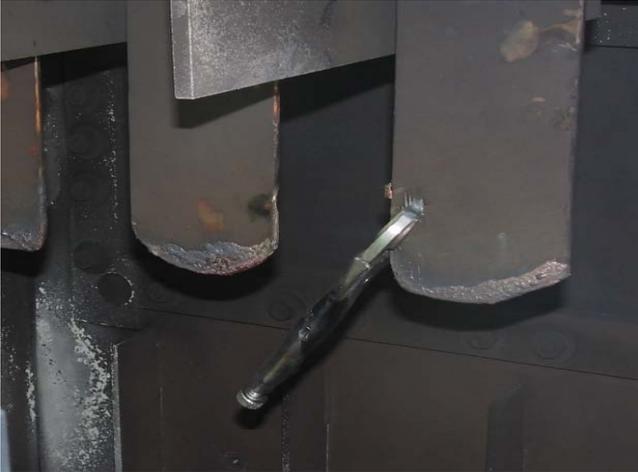
Fig. 37. After fault initiated by tool

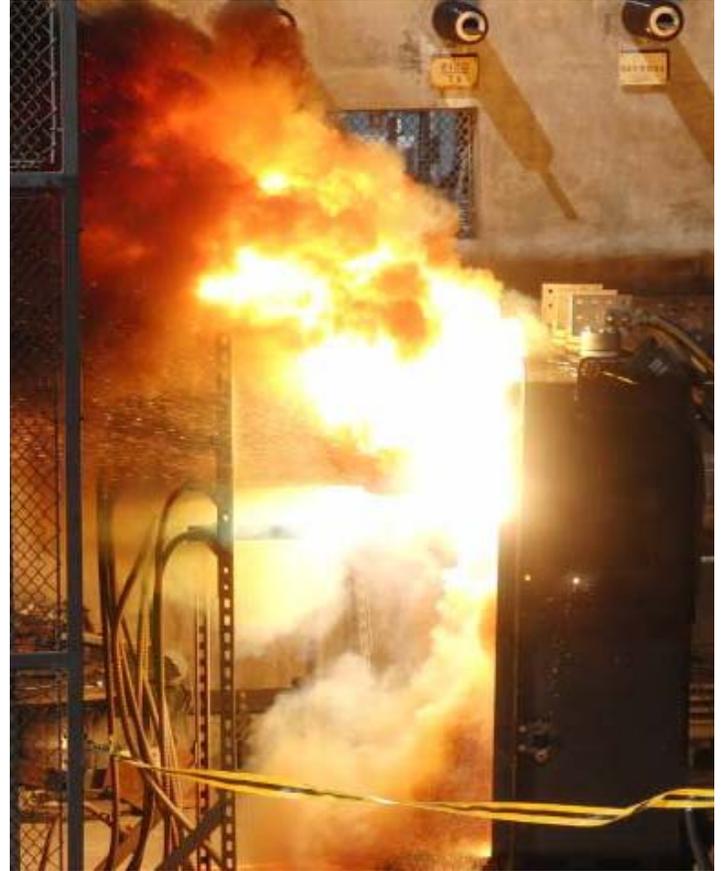
In order to assess how confinement impacts arc sustainability, a metal ground plane was added behind and below the bus bar, as shown in Fig. 38. In this configuration, faults were able to sustain and did not clear until the laboratory protection tripped the circuit. Fig. 39 shows the arcing event.

Fig. 39. Network protector arc event

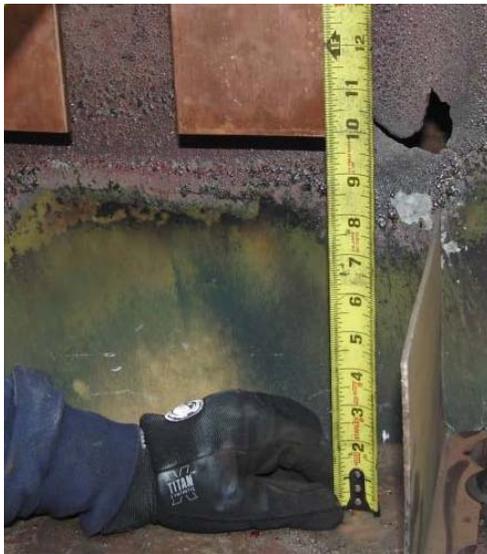
Fig. 41. Ground plane 10" away (event 270)

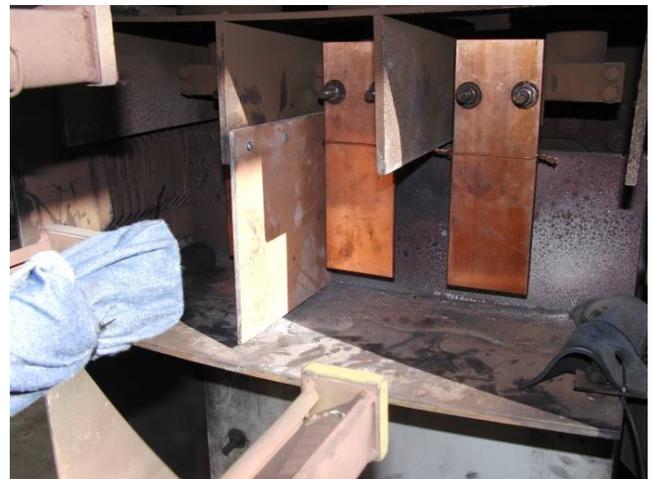
Network protectors normally have mica dividers that separate bus bars. Fig. 43 shows a test setup with a mica divider separating one bus bar from the other two bus bars that are shorted with a 12-AWG copper wire.

Fig. 43. Test configuration with mica dividers

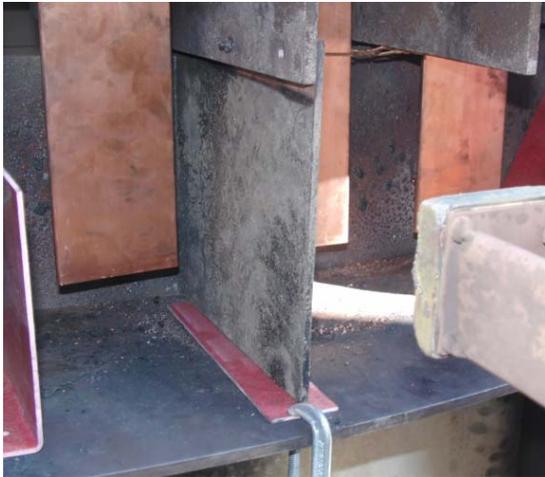
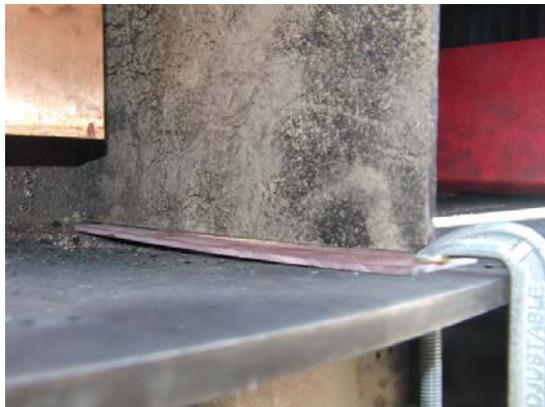
Fig. 44 shows that even with the mica divider (event 265), the fault escalated to phase C in less than one half cycle. With a reduced gap between the mica divider (event 266) and the ground plane, the fault still escalated quickly (Fig. 45 and Fig. 46).

Fig. 45. Reduced micarda spacing
