ARC FLASH TESTING OF TYPICAL 480-V UTILITY EQUIPMENT

Abstract – A test program was completed to measure arc flash incident energy from actual 480-V utility equipment to determine the most appropriate flame resistant clothing for utility workers. The equipment tested included self-contained and CT-rated meters, padmounted transformer secondary cubicles, power panels, and network protectors. Testing was performed to determine the sustainability of low voltage arcs in actual utility equipment, the most appropriate calculation method to predict the measured incident energy, and to identify any key variables that would effect both duration and heat from this type of equipment.

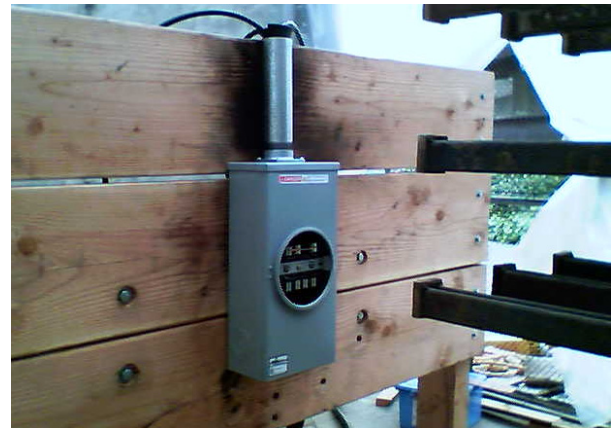
Standard seven jaw (type 16S) self-contained three-phase 480-V meter bases were mounted to a back board as shown in Fig. 1. Incident energy was measured by nine copper calorimeters on stands spaced 8" apart and positioned 18" away from the meter jaw. Calorimeters were built and calibrated according to ASTM specifications [7, 8].

Fig. 1. Self-contained meter test setup

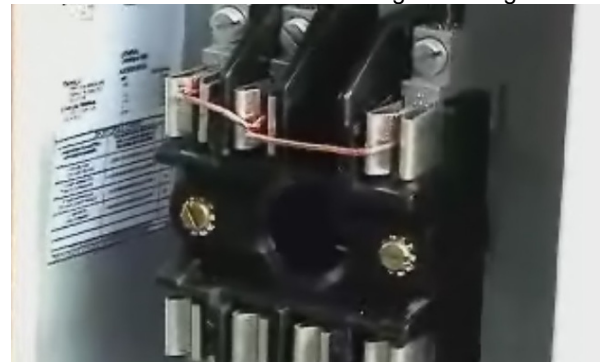
The line side of the meter base was shorted across three phases with a solid 12-AWG wire, as shown in Fig. 2. Testing was conducted at four different values of bolted fault current: 6.6 kA, 12.7 kA, 25.7 kA, and 44 kA. All test events were allowed to continue until the arcing self extinguished.

Fig. 2. Shorting wire used to start the fault

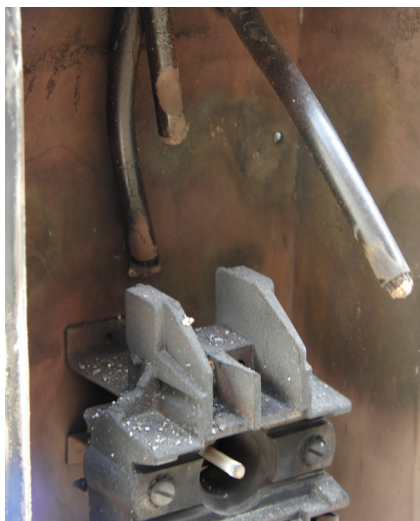
Test data is shown in Table 1 for incident energies measured at 18 inches from the calorimeters. As shown in Fig. 3, the majority of the events ended when all of the copper from the line side meter jaws had vaporized along with the 1/0 copper lugs that attached the power source to the meter base.

Fig. 3. Meter base after a fault

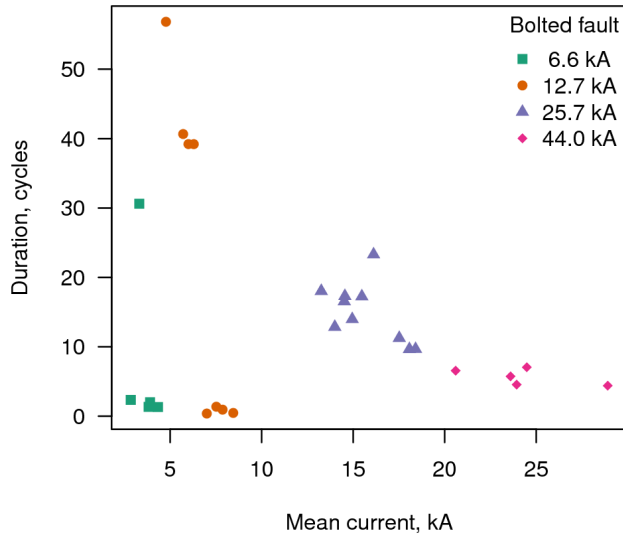
Fig. 4. 480-V meter arc duration vs. arcing fault current

All events provided a focused energy stream. The calorimeter directly in front of the meter often had at least twice the incident energy of the calorimeters on either side (offset by eight inches). The middle calorimeter takes much more of a direct hit from the hot plasma generated by the arcing. Lower currents led to higher incident energy because of longer duration, as shown in Fig. 4. At higher currents, the available copper at the top of the meter base vaporized quickly, and the event self-extinguished in well under 200 msec; see Fig. 5. The highest incident energies were recorded at the 12.7-kA tests, with 20.1 cal/cm² being the highest. The cutting-torch action of the 12.4-kA arc may be spraying copper into the arc channel, increasing the likelihood that the fault continues to arc. At 6 kA, the faults apparently are not energetic enough to keep the arc channel sufficiently ionized to maintain the fault. The meter test results highlight the importance of self clearing at 480 V.

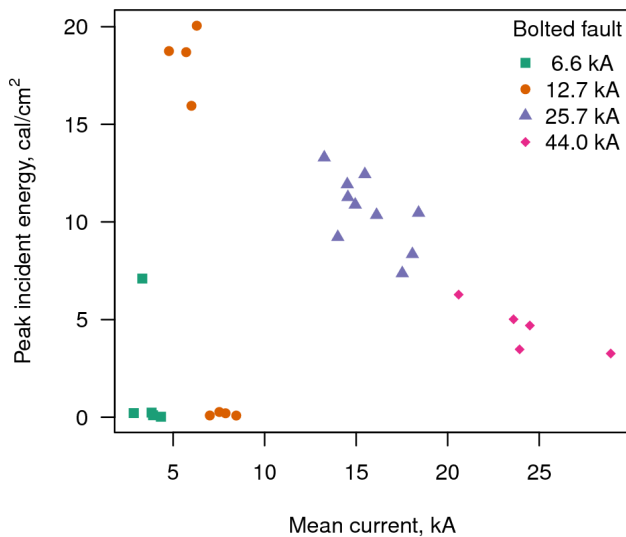
Fig. 5. 480-V meter incident energy vs. arcing fault current

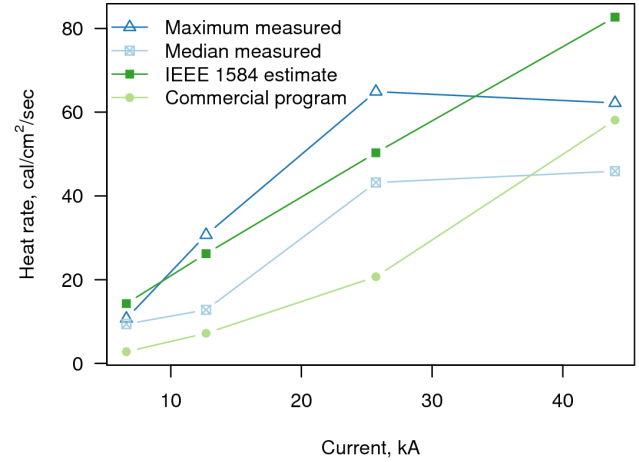
Comparing the measured maximum heat flux rates to two different calculation methods, IEEE 1584 and commercially available software shows that the IEEE 1584 more closely predicts the heat flux rate at lower available fault currents. Neither modeling approach predicts the leveling off of heat rate seen in the measured data between the 25kA and 44kA bolted fault currents, as shown in Fig. 6.

Fig. 6. Measured vs. calculated heat flux for self-contained 480-V three phase meters

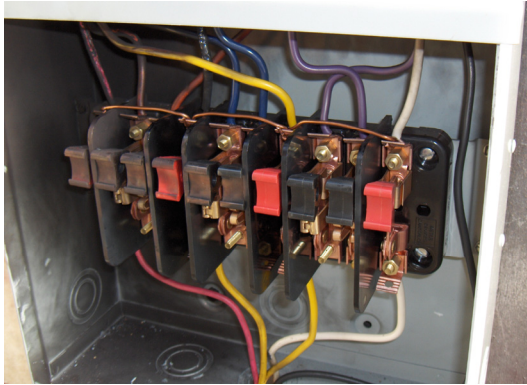
Standard thirteen jaw (type 9S) transformer rated three-phase 480-V meter bases were mounted to a back board. All meters were wired with a 10-AWG wire between the main power panel and the meter panel. Incident energy was measured by nine copper calorimeters mounted on stands spaced 8" apart and positioned 18" away from the meter jaw. Arcing was initiated at two different locations in the meter enclosure. The meter base was shorted with 22-AWG wire for one set of tests as shown in Fig. 7, and then the switch block was shorted with 14-AWG wire as shown in Fig. 8.

Fig. 8. Shorting wires in the switch block

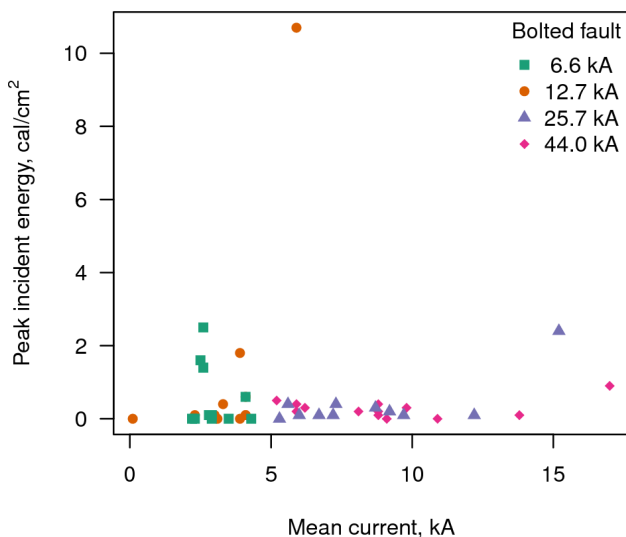
In all cases the arcing current was severely limited by the 10-AWG wire providing power to the transformer rated meter panel. This effectively extinguished the arc rapidly in all 45 events. Only one of the events measured above 8 cal/cm², test number 166 which measured a peak value of 10.7 cal/cm². The remaining 44 events measured less than 2.5 cal/cm², as shown in Fig. 9.

Fig. 9. Arcing current vs. incident energy for 480-V CT rated meters

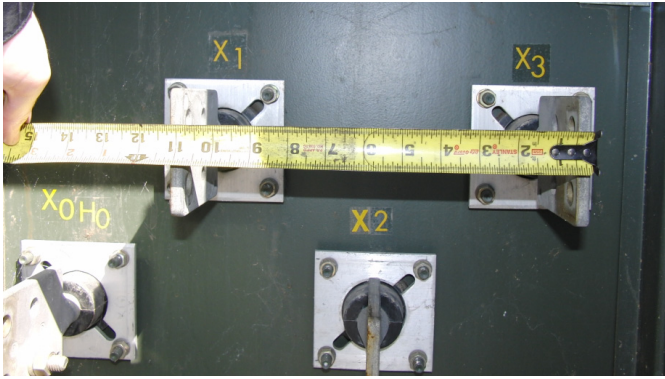
Fig. 10 shows the spacing of the secondary terminal configuration of the unit used for testing. The internals of the transformer were removed, and voltage was supplied to the secondary terminals from the back side from the 480-V fault current source.

Fig. 10. 480-V padmounted transformer secondary terminals

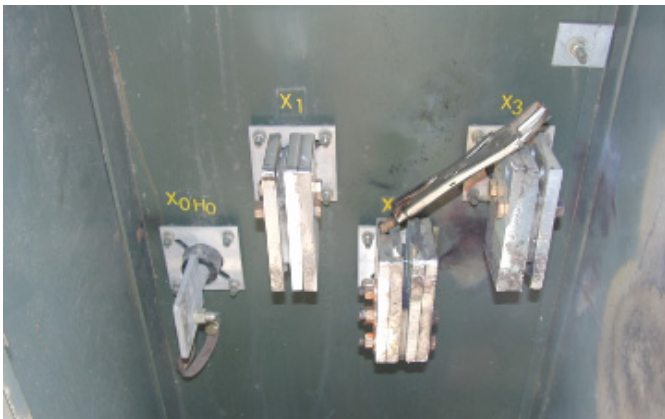
Fig. 11 shows a typical fault test initiated with a pair of vice grips laid across phases. The phase spacing in this configuration is approximately 2.75 in. This phase gap was progressively shortened by adding plates to see if tighter spacing would cause the arc to sustain.

Fig. 11. Vise grip initiated test setup

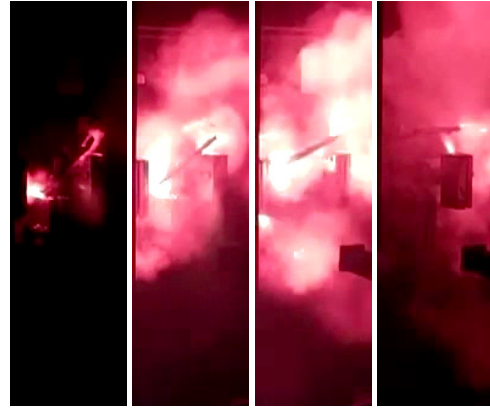
Fig. 12 shows a progression of high-speed video frames taken. The event lasted less than two cycles as shown in Fig. 13. Note that the event progressed from a line-to-line fault to a three-phase fault in less than a quarter cycle.

Fig. 12. 1200-fps video snapshots through an infrared-passing filter

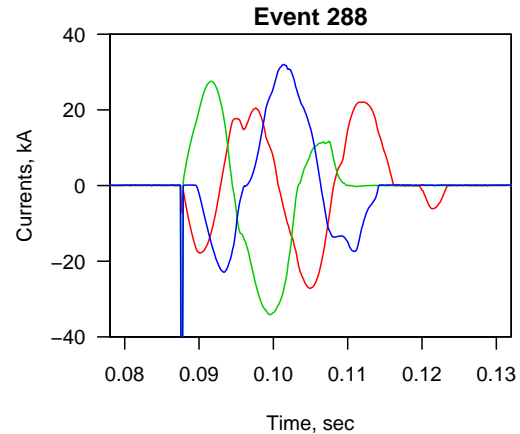
Fig. 13. Current waveforms for a wrench event

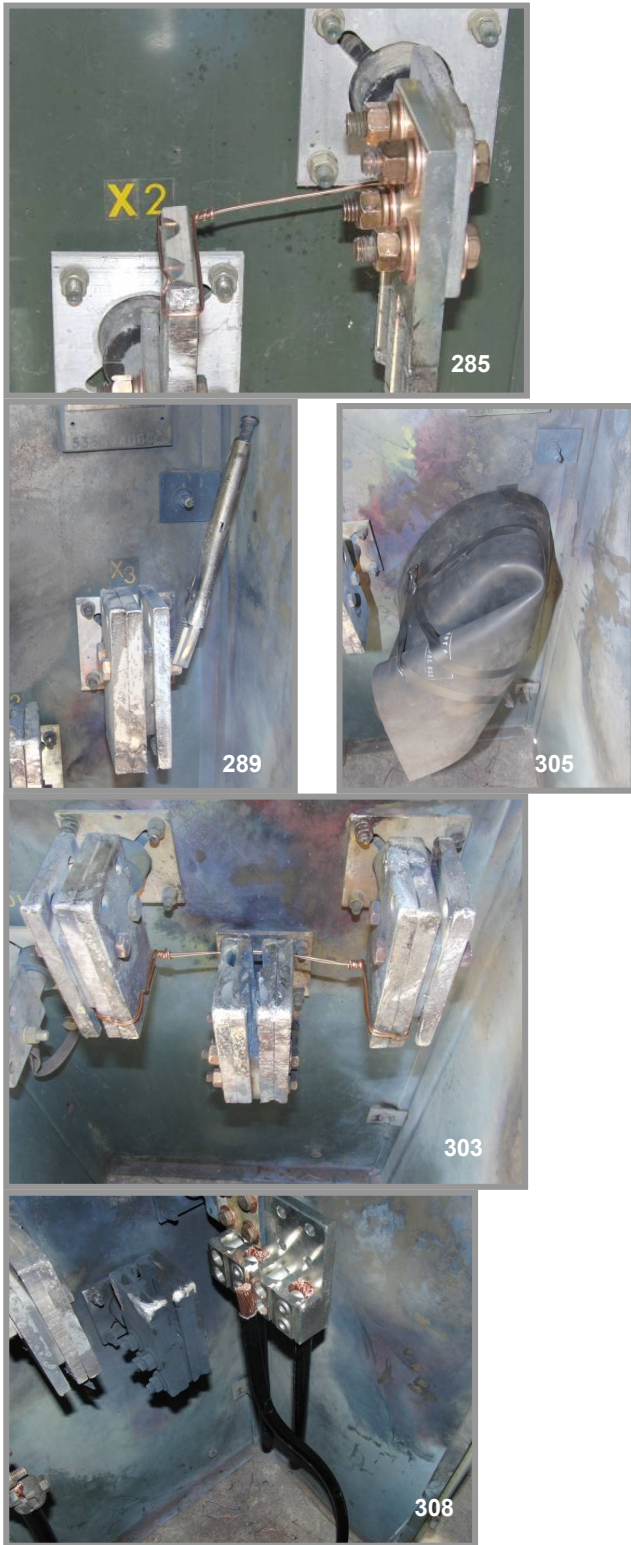
Fig. 14 shows several fault initiations that were tested. Both phase-to-ground and phase-to-phase faults were attempted. Some common observations include:

Faults generally became three-phase faults within a half cycle (with the exception of event 289 where the main point of the arc initiation was well away from other phases).

Even to distances as close as two inches, faults could not sustain. The arcs grow into the open space around the electrodes until they cannot sustain. Arcs were first initiated at a distance of 3.7 inches and shortened until reaching two inches.

This did not seem to change arc duration characteristics. Bolted fault currents of 13, 28, and 53 kA were tested.

Fig. 14. Fault variations tried

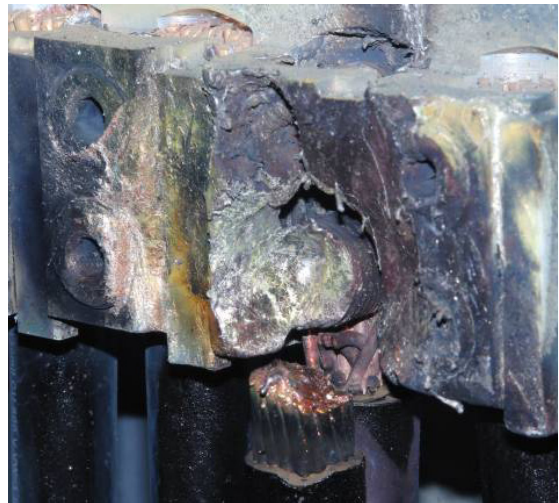
Fig. 15 shows damage after test 310, a phase-to-phase connection similar to test 308 in Fig. 14. This test was made more severe by taping the incoming cable to adjacent conductor stubs to prevent cable movement. This event cleared in less than 12 cycles. We see that the cable and aluminum alloy connector both burned away, apparently until the gap was large enough for the arc to self clear. As this was the most severe event found so far, this fault scenario was tried at other spacings and fault currents. Fig. 16 shows an example tested at a spacing of less than two inches. Faults still cleared within 12 cycles. Fig. 17 shows waveforms for some of the longer-duration events.

Fig. 15. Results after event 310

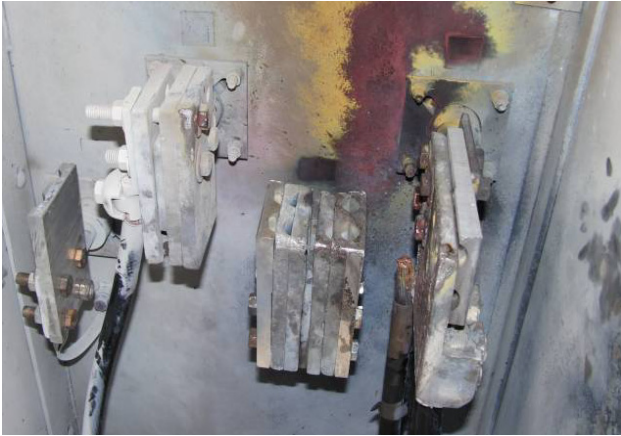
Fig. 16. Event 317: two-inch gap between phases

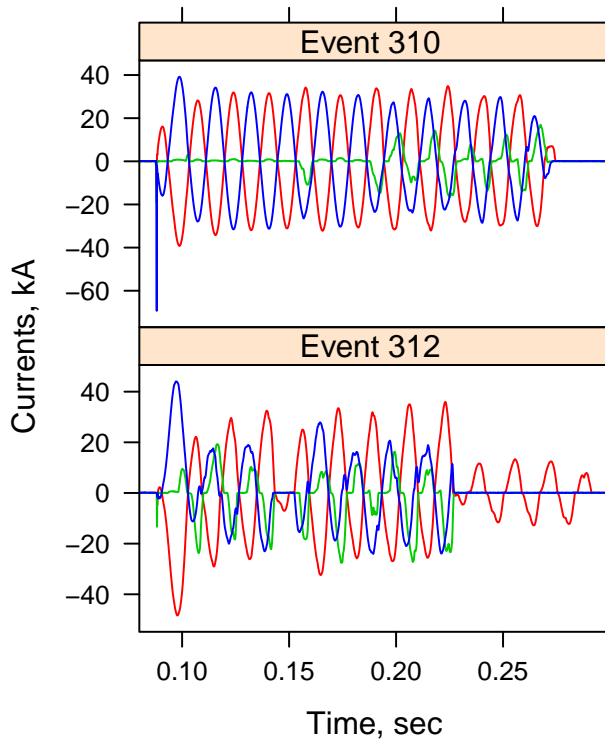
Fig. 17. Waveforms from the longer duration events

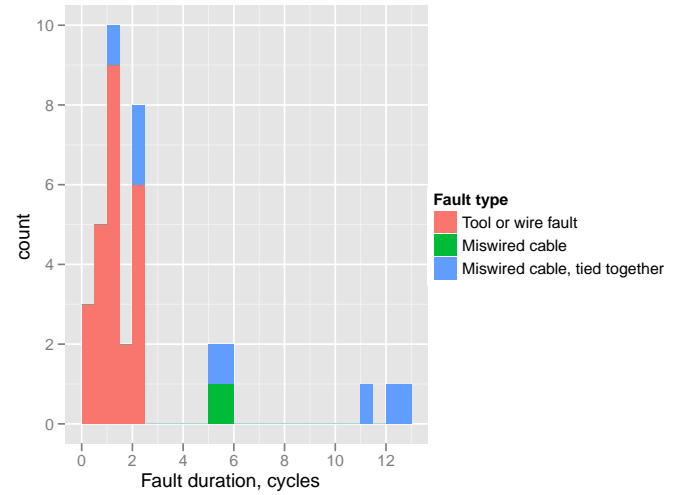
Fig. 18 summarizes the fault durations observed from the 35 tests with fault type shown by color. The “miswired cable” indicates the tests with the 500-kcmil conductor jumpering ground to phase or phase to phase, either tied down to adjacent stubs or free. Fig. 19 shows distributions of incident energies measured at 21 inches from the fault location.

The durations show that the arcs cannot sustain long in secondary compartments with typical or even tighter-than-

normal conductor spacings. Because the duration is short, incident energies are low, with no event exceeding 4 cal/cm^2 .

Fig. 18. Fault duration histogram

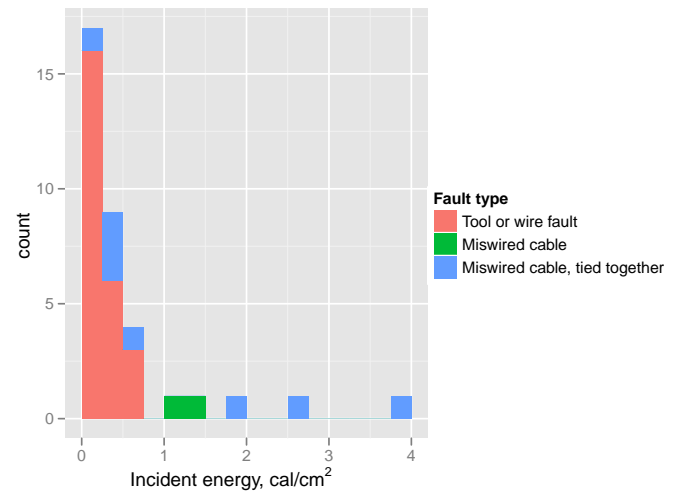
Fig. 19. Incident-energy histogram

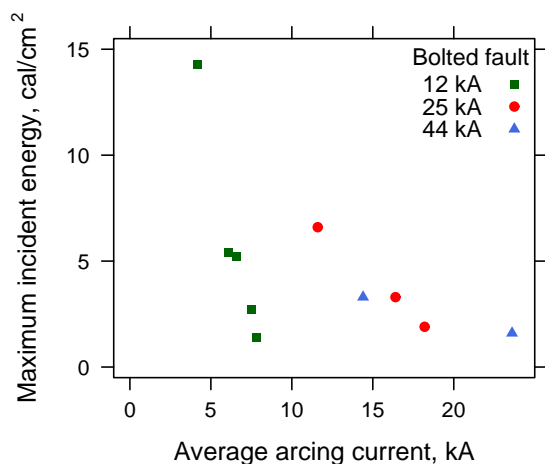
Table 3 shows results from tests of 50-A and 100-A rated panels. The arc event usually ended when the bus bracing failed which allowed the bus bars to separate and increase the arc length beyond the sustainable limit. The maximum incident energy measured was 14.3 cal/cm^2 . At higher available fault currents, faults self-cleared faster and led to lower incident energies as shown in Fig. 20 and Fig. 21. The

Fig. 20. Maximum incident energy from 50-A and 100-A panels

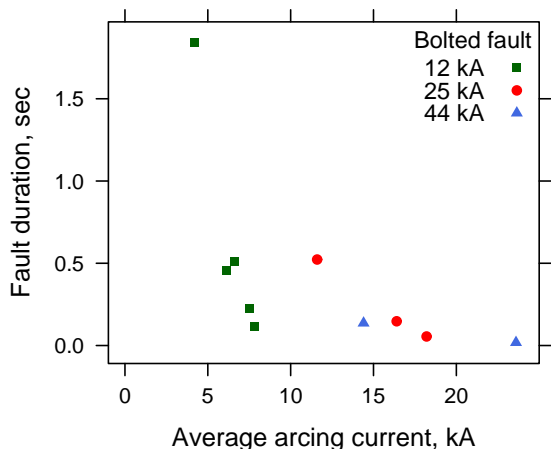
Fig. 21. Fault duration from 50-A and 100-A panels

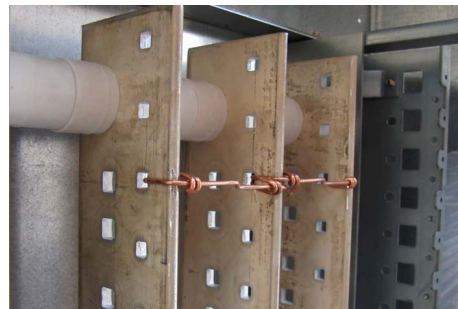
For two higher-rated panels, results were much different—faults did not self clear like they did with meters and smaller panels. Fig. 22 shows the 250-A panel prior to testing.

Fig. 22. 250-A power panel prior to test

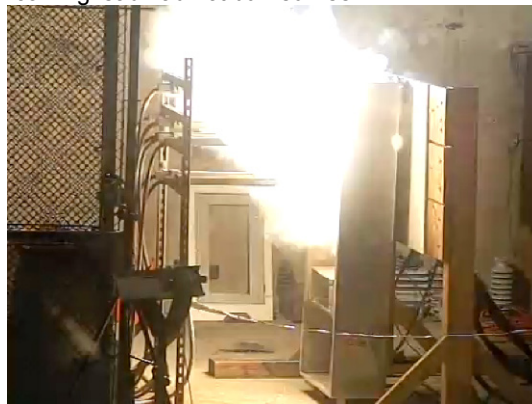
Fig. 23 shows a video frame from this event. The event caused an incident energy of almost 48 cal/cm² at an 18-in working distance which is considerably more than measurements on any of the smaller panels or meters. This test configuration had an available bolted fault current of 25.7 kA and a measured average arcing current of 14.8 kA.

This event lasted for 0.74 sec and did self clear. However, it did not clear in the same manner as the smaller panels. One of the incoming 480-V leads at the bottom of the panel burned free, probably from rubbing against the frame. This acted like a fuse that helped clear the fault. Based on the video evidence and the condition of the bus work in the cabinet, it is likely that the fault would have continued to arc if the incoming lead had not burned free.

Fig. 23. 250-A power panel for test 232

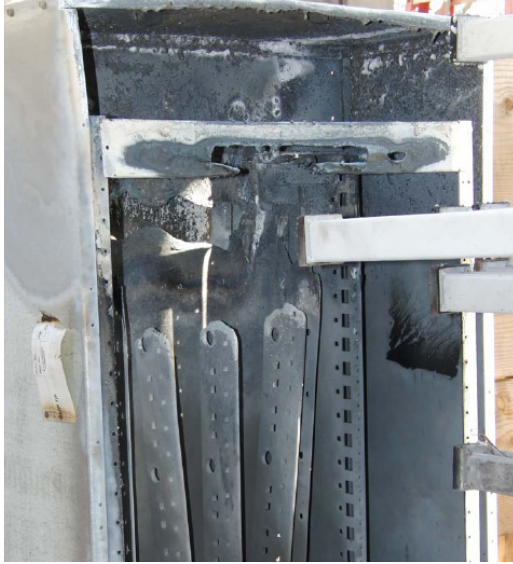
Fig. 24 shows an identical panel after another test. This fault heavily damaged the calorimeter array, and the panel enclosure suffered significant damage. This event did not self clear. The fault was cleared by laboratory protection just prior to two seconds. Incident energies likely exceeded 140 cal/cm². Fig. 25 summarizes the measurements during this test. This fault had almost three times the arc energy in the fault as test 232. The event showed no signs of self clearing as the smaller panels and likely would have continued until all the bus had been consumed.

Fig. 24. 250-A panel after test 233

The amount of bus bar burned in the panel in test 233 matched closely with the Stanback equation. The panel had 3.25×0.25 inch aluminum bus bar, and approximately eight inches was burned from each phase. Based on these measurements, the bus volume consumed was:

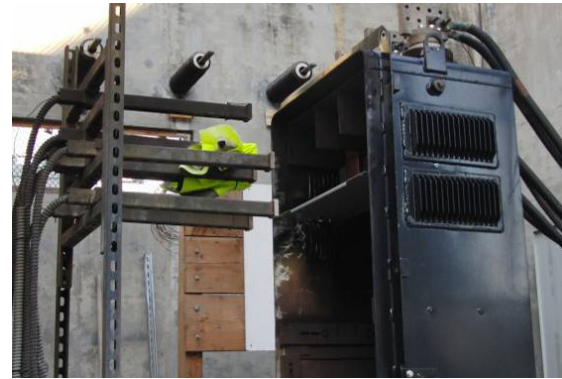
Fig. 26 shows the network protector used during tests. The internal operating mechanisms have been stripped from the unit. The unit is energized from the top, which is the network side of the unit. A common work procedure is removing the fuses on the network feed. Bus bars from the top were included in the box. The unit is fed by a 480-V source that's capable of supplying a bolted fault current of 52 kA.

Fig. 26. Network Protector Test Setup

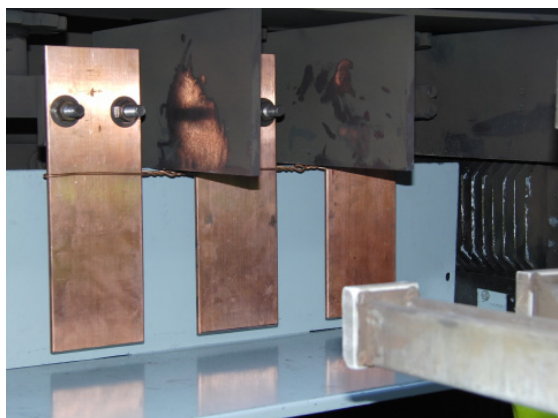
In order to assess how confinement impacts arc sustainability, a metal ground plane was added behind and below the bus bar, as shown in Fig. 27. In this configuration, faults were able to sustain and did not clear until the laboratory protection tripped the circuit.

Fig. 27. Configuration with metal ground plane

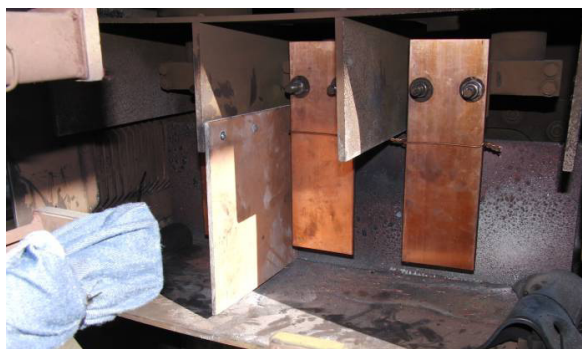
Network protectors normally have micarda dividers that separate bus bars. Fig. 28 shows a test setup with a micarda divider separating one bus bar from the other two bus bars that are shorted with a 12-AWG copper wire.

Fig. 28. Test configuration with micarda dividers

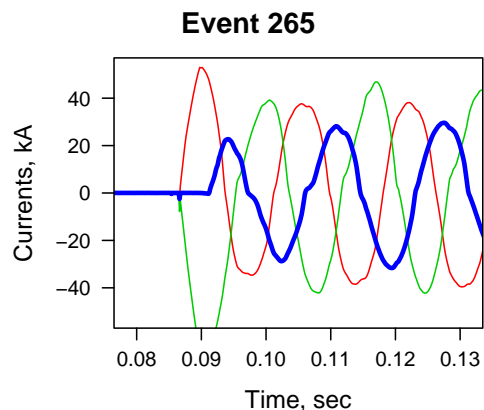
Fig. 29 shows that even with the micarda divider (event 265), the fault escalated to phase C in less than one half cycle. With a reduced gap between the micarda divider (event 266) and the ground plane, the fault still escalated in less than $\frac{1}{2}$ cycle.

Fig. 29. Current waveforms with micarda spacers

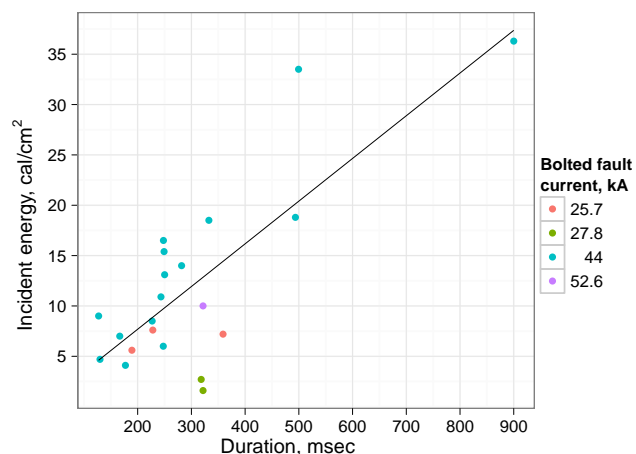
This section documents many of the calorimeter incident-energy readings obtained during the network protector tests. Unless otherwise stated, these incident energies were measured 18 in from the arc initiation point. Fig. 30 shows how incident energy varied with duration. For the cases with a bolted fault current of 44 kA, the incident energy was reasonably linear. Fig. 31 shows the relationship between arc energy and incident energy, and it is reasonably linear across fault current ranges. Fig. 32 shows that the ratio between arc energy and incident energy is not strongly duration dependent, meaning that the incident energy is directly related to arc energy without an extra effect caused by duration. Fig. 33 shows that arc power and incident heat rate also track linearly. These graphs support two basic assumptions used in IEEE 1584 and other analysis: (1) incident energy increases linearly with fault duration, and (2) incident energy is linearly related to arc energy.

Fig. 30. Incident energy vs. duration

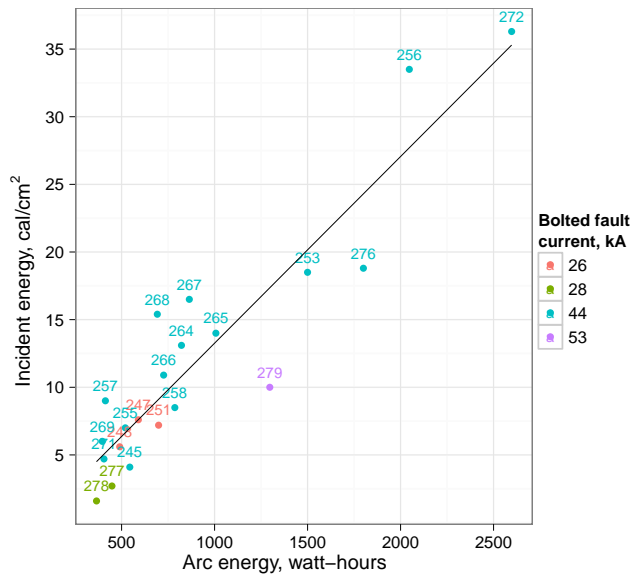
Fig. 31. Comparison of incident energy to arc energy

- 245: The test did not have the plate behind the bus bars (only below), possibly allowing more of the blast to go down the enclosure rather than out the front.
- 256: The shelf below the bus bars blew out; the maximum readings were on the bottom calorimeters which was unusual.
- 257: Arc power was underestimated some because the middle-phase voltage was lost for two out of seven cycles.
- 267 & 268: Configuration had a larger bus gap: 4" and 6", so the plasma may have been directed differently.
- 272: Arc energy was underestimated by about 10%; only 90% of the waveform was captured.

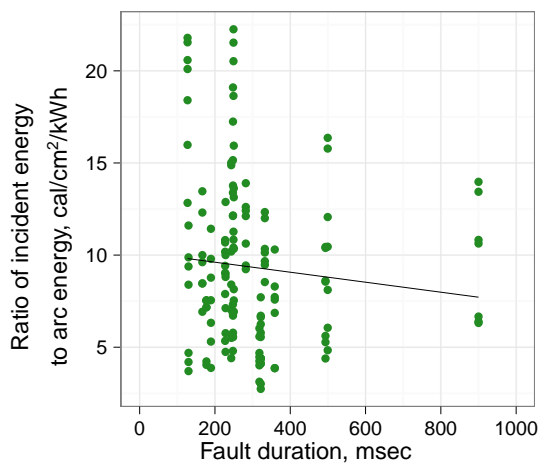
Fig. 32. Energy transfer ratio vs. fault duration

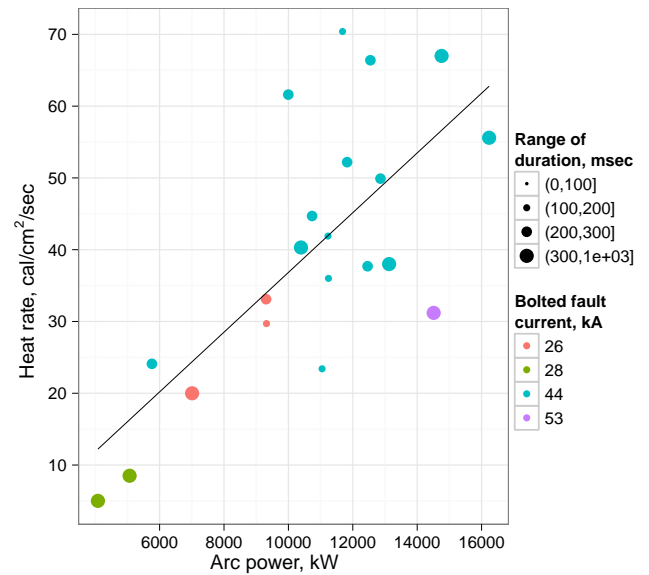
Fig. 33. Arc power vs. incident heat rate

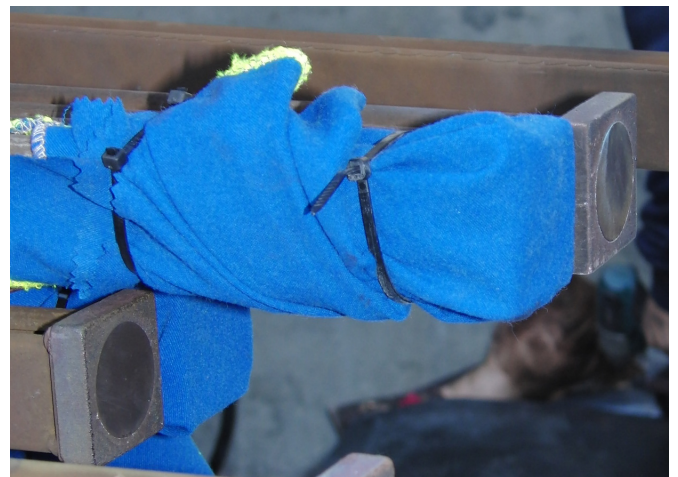
In many tests, calorimeter measurements were taken at different distances as shown in Fig. 34 with the closest calorimeters at 18 in and the back calorimeters at 24 in from the arc initiation point. The measurements at each location track closely as shown in Fig. 35. The slope of the linear fit to Fig. 35 is 0.52, which equates to a distance factor of 2.3. This is higher than the distance factor of 1.473 used in IEEE 1584 for low-voltage switchgear. Note that in this configuration, the front calorimeters are located such that they may have shielded the back calorimeters. This shielding may have reduced the energy to the back calorimeters enough to produce an artificially high distance factor.

Fig. 34. Calorimeter arrangement

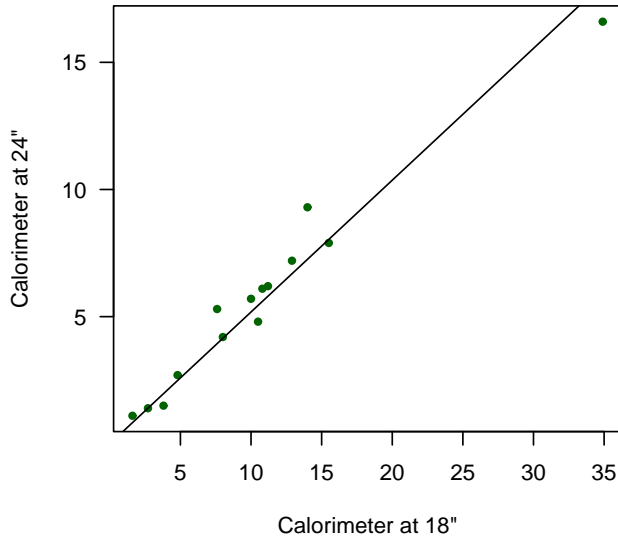
Fig. 35. Incident energy measured at different distances

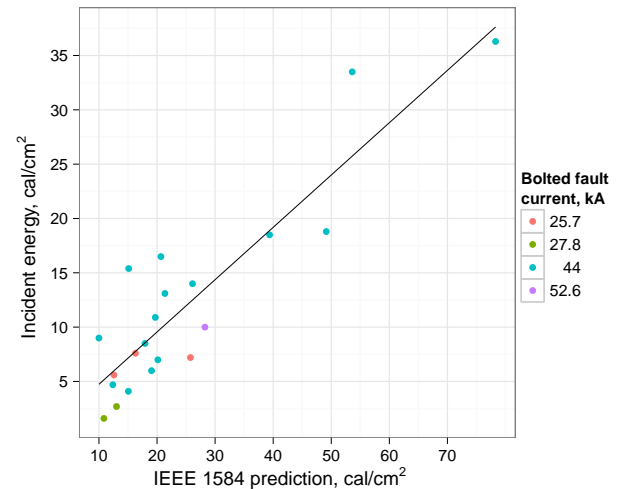
IEEE 1584 comparison A

Comparison A – Fig. 36, meant to replicate the test more precisely – Actual fault current for each test is used along with the network protector bus bar gap of 2.5 in.

Fig. 36. Measured incident energy vs. calculated (with IEEE 1584 using gap = 2.5" and actual arcing current)

Fig. 36 and Fig. 37 shows two different evaluations of the IEEE 1584 calculated incident energy estimates and the network protector test results. The y-axis values are the measured incident energies. The x-axis values come from IEEE 1584 estimates using the duration and currents from the test. The differences are as follows:

Both comparisons show that IEEE 1584 generally over predicts incident energies. Actual measurements are generally 30 to 75% of the IEEE 1584 prediction.

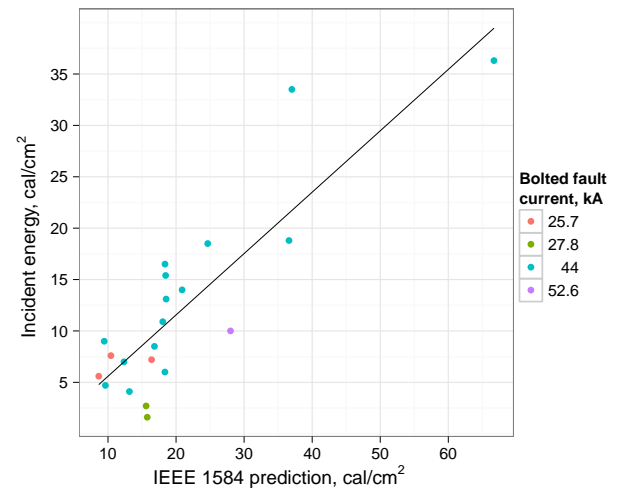
IEEE 1584 comparison B

Comparison B – Fig. 37, meant to replicate the default IEEE 1584 calculation – Bolted available fault currents are used along with the default gap distance of 1.25 in specified in IEEE 1584 for low-voltage switchgear.

Fig. 37. Measured incident energy vs. calculated (with IEEE 1584 using gap = 1.25" and bolted fault current)

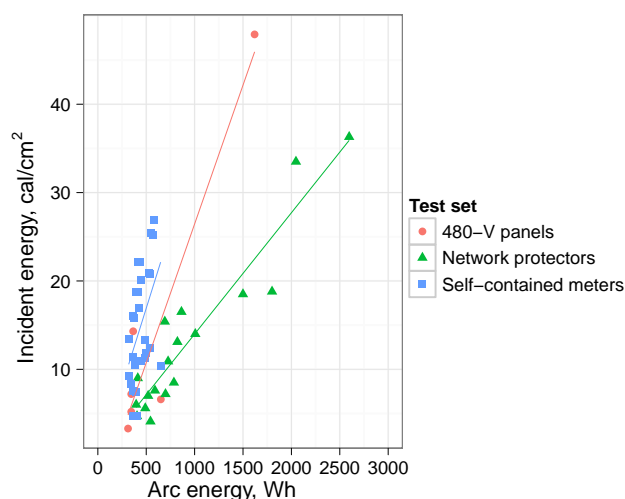
Fig. 38 compares the network protector, power panel, and self-contained meter test results. This graph shows how much of the energy is transmitted from the arc to the

Fig. 38. Comparison of incident energy and arc energy

Energy focusing – The small meter housing focuses the arc energy straight out of the box in a relatively tight pattern. The larger network protector enclosure has less of a focusing effect, but the incident energy impacts a much wider area. Fig. 39 and Fig. 40 show two typical events. The shape of the enclosure and the magnetic fields determine how the arc energy is released.

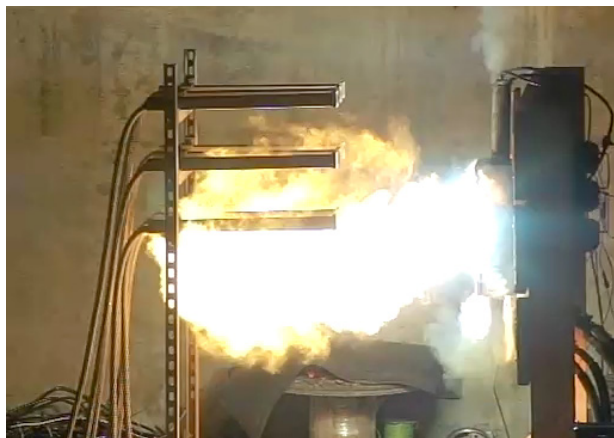
Fig. 39. Typical meter arc flash

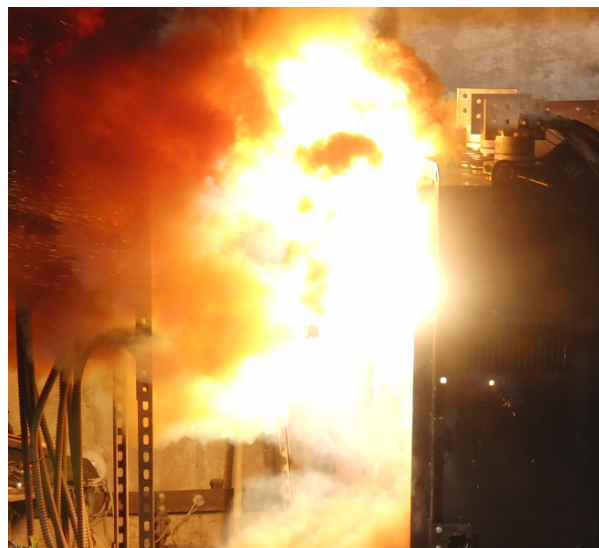
Fig. 40. Typical network protector arc flash
