Medium-Voltage Arc Flash in Switchgear and Live-Front Transformers

Abstract—Arc flash on distribution circuits is a safety issue that can impact work practices for line and substation workers. This paper shows test results for arc flash events in medium-voltage switchgear cubicles and live-front transformer enclosures. Both scenarios can result in more incident energy than the prediction of IEEE 1584-2002. Much higher than expected energies were measured from rack-in style switchgear breaker cubicles due to the orientation of the electrodes. Live-front transformer cubicles showed wide variability that was not directly related to the enclosure size or arc directionality. Unexpectedly high energies were measured in multiple configurations. For selection of the appropriate clothing systems, incident energy multipliers are suggested based on IEEE 1584-2002.

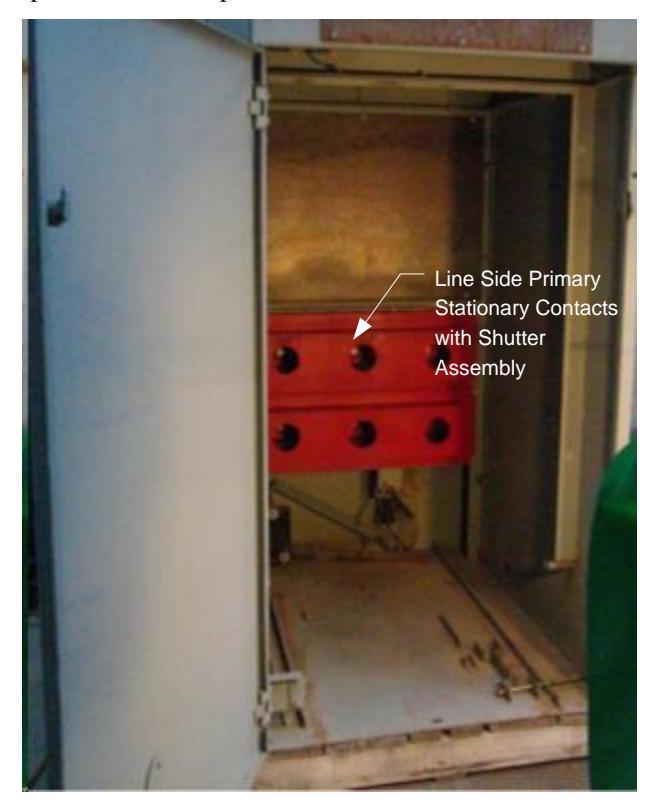
Fig. 1. Horizontal, rack-in style switchgear cubicle tested

Three older-style rack-in switchgear cubicles were obtained. These units were single breaker full size cubicles with the breaker going in the bottom half of the switchgear cubicle. The stationary primary contacts (electrodes) inside the cubicle were surrounded by a ceramic insulating bottle. The bottle assemblies are normally covered by a phenolic bottle barrier and shutter assembly that shields the normally energized parts from direct contact when the breaker is removed from the cubicle. The shutter assembly was removed for testing, but the bottle barriers were left in place for the first test shot in each cubicle section. See Figure 1. The interior dimensions of the cubicle were 33×69.5×39 in (83×142×149 cm) with the line side stationary contacts pointing out of the back wall of the cubicle towards the front with 10 in (25 cm) of separation between phases and approximately 30 in (76 cm) up from the bottom of the cubicle. The "rack-in" style was also tested with a simulated breaker inserted into the cubicle.

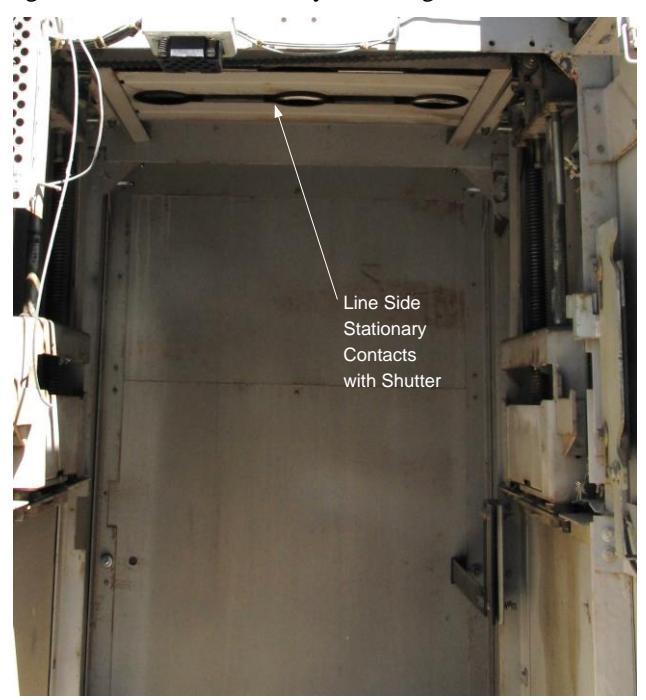
Three full-size cubicles with the breaker going in the bottom of the switchgear and racking up after insertion were tested. The shutter assembly was removed for testing. See Figure 2. The interior dimensions of the cubicle were $36 \times 56 \times 58.5$ in $(91 \times 142 \times 149 \text{ cm})$ with the line side stationary contacts

pointing down from the top of the cubicle at approximately 24 in (61 cm) from the front edge. There was 9.5 in (24 cm) of separation between phases.

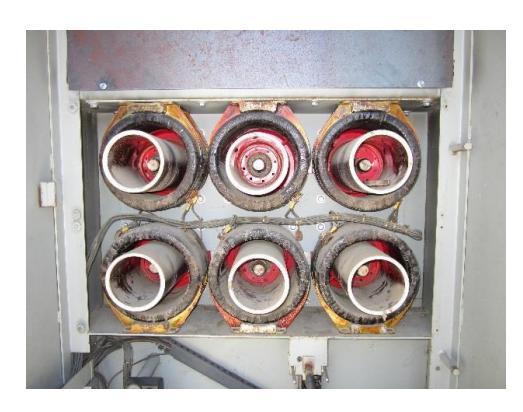
Fig. 3. Horizontal, rack-in style; stationary contacts shutter removed

The stationary primary contacts were potted into a single metal flange for each of the three phases for both the line side and the load side. The majority of the ceramic bottles surrounding the stationary contacts were on the bus side of the cubicle instead of the breaker side of the cubicle. This is distinctly different from the rack-in style. See Figure 3 and 4. Incident energy measurements were made in front of the cubicle

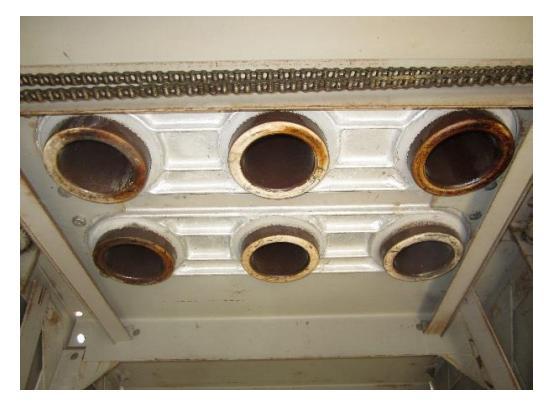
Fig. 4. Vertical, rack-up style; stationary contacts shutter removed

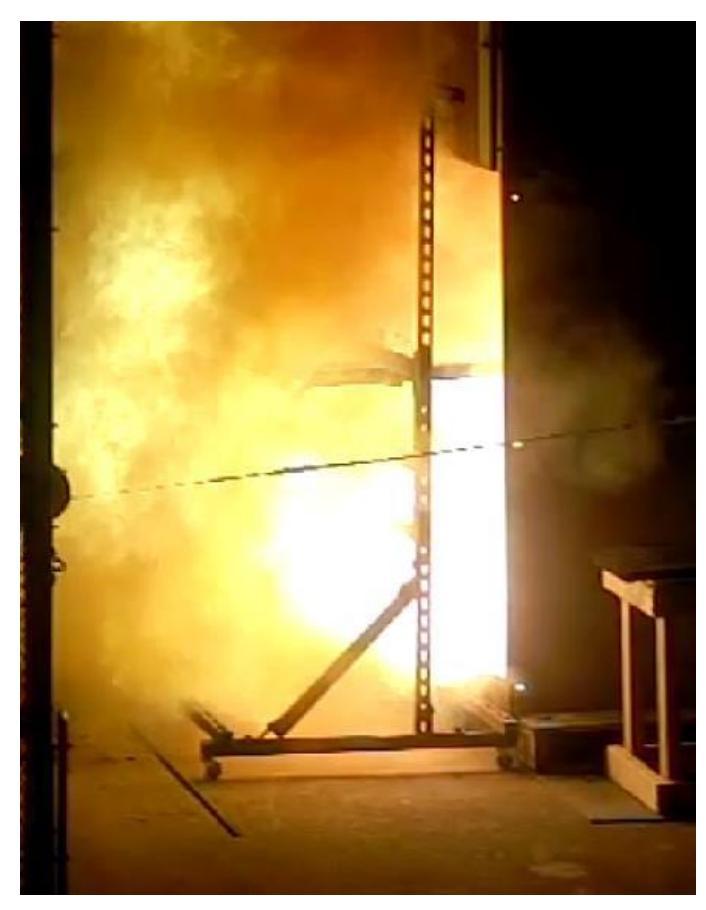
Fig. 5. Test ID 6: 5.7 kA, 30 cycles, 13 cal/cm² max, 10.4 cal/cm² avg., 25.6 cal/cm²/sec heat rate

When the calorimeter array was spaced 36 in (0.9 m) from the back wall of the enclosure, it was about 3 in (7.6 cm) inside the front plane of the opening. During the longer events—30 cycles or longer—a large arc plasma (fireball) projected out of the enclosure and enveloped the calorimeters. See Figure 5.

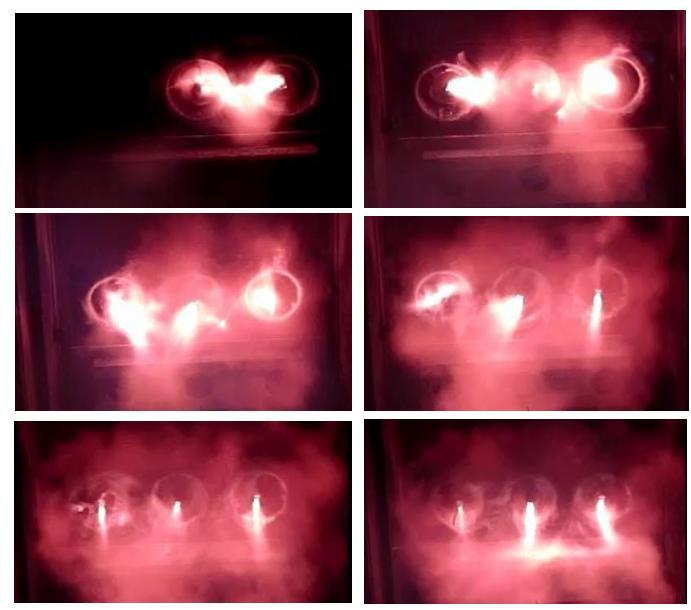
Fig.6. Video frames from test ID 40 for the first six frames (300 fps) viewed through an infrared-passing filter

Arcing for all events was very similar. As shown in Figure 6, the arc starts between phases with the fuse wire but quickly moves to the case and arcs around the bottom of the CTs and to the side wall.

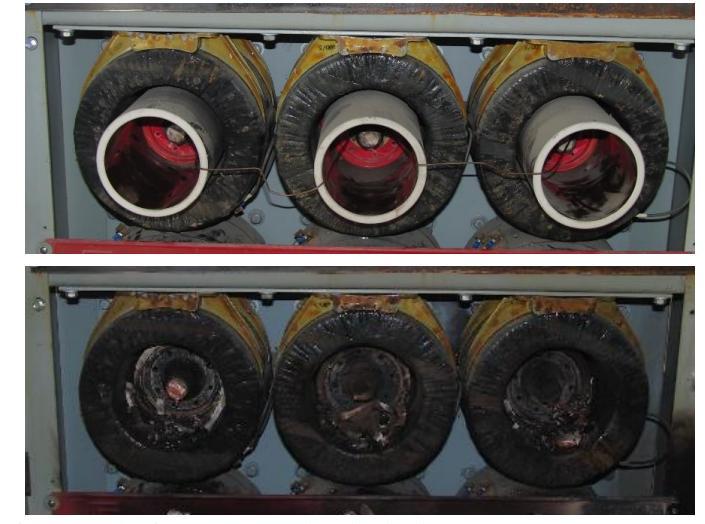
Fig 7. Bottles intact TOP vs bottles broken BOTTOM

When the ceramic bottles were in place, the arcing pattern was similar, but the arc lengths were extended. Even with extended arcs, the measured incident energies were reduced. This is due to the absorption of the energy by the ceramic bottles. The ceramic always broke, and in the process, some of the energy was used to heat and break the ceramic, leaving less to be ejected out of the cubicle onto the calorimeters. Due to the limitations of available hardware and destructiveness of the testing, the three samples were used to their maximum limitations i.e. much of the testing was conducted with broken bottles. See Figure 7.

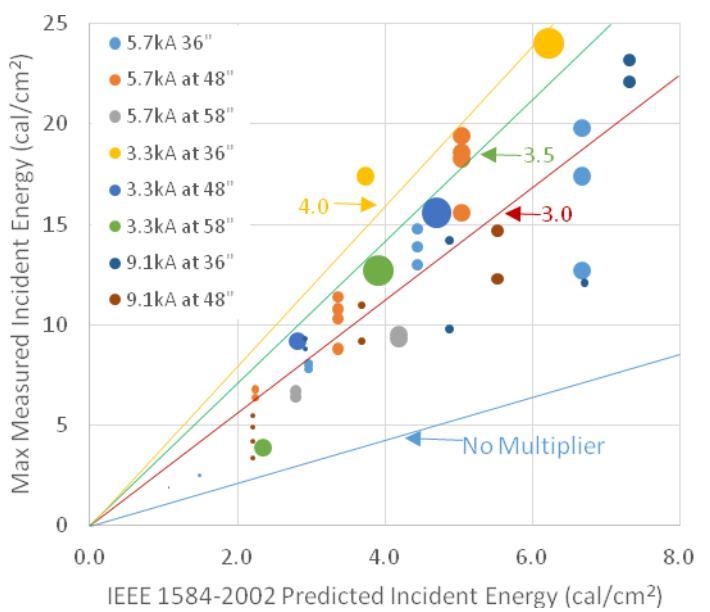
Note 1: Bubble size reflects arc durations of 5.8, 10, 12, 20, 30, 45, 75 cycles respectively. Lines represent multipliers to IEEE 1584-2002. Fig 8. Horizontal switchgear: measured vs. predicted energy

Measured heat rates were fairly linear with time and with magnitude of arcing current. However, the Figure 8 shows that measured incident energies significantly exceeded the IEEE 1584-2002 switchgear formula. Multipliers of 3.0 to 4.0 would be needed to accurately predict resultant incident energies. See Figure 8. Longer events would be more likely to be at the higher end multiplier (a 3.0 multiplier encompasses all the events that were 20 cycles or less in duration). See Table 1 for the overall probability that each multiplier encompasses all the test data points.

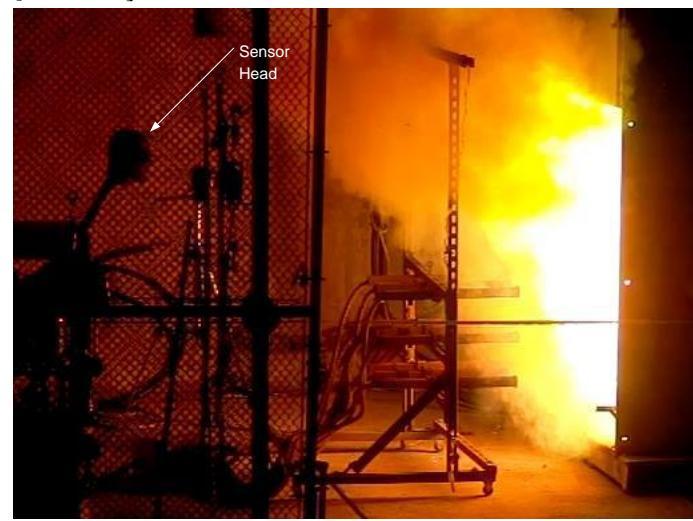
Fig. 9. Test ID #134- 3.3 kA, 45 cycles, calorimeter array at 58 in (147 cm) from arc, image at or very near end of the event

Figure 9 shows that the heat rises significantly above the sensor head (located 10 ft. [3 m] away from the arc). This is true for all cases. The measured energy at the sensor head was a fraction of what IEEE 1584-2002 predicts. This will significantly reduce the arc flash boundary predictions from those previously done. Actual measurements at 10 ft. (3 m) varied from 40% to 90% of what IEEE 1584 would predict, with the bulk at 50% to 60%. This is an indicator that the "distance factor" relationship is finite at some boundary point. Beyond 5 ft. (1.5 m) away from the arc, a different formula would need to be developed to determine the real arc flash boundary (the point at which incident energy would fall below 2 cal/cm², the OSHA limit for FR clothing protection) [Paragraph (1)(8) of §1910.269, 2014 and Paragraph (g) of §1926.960].

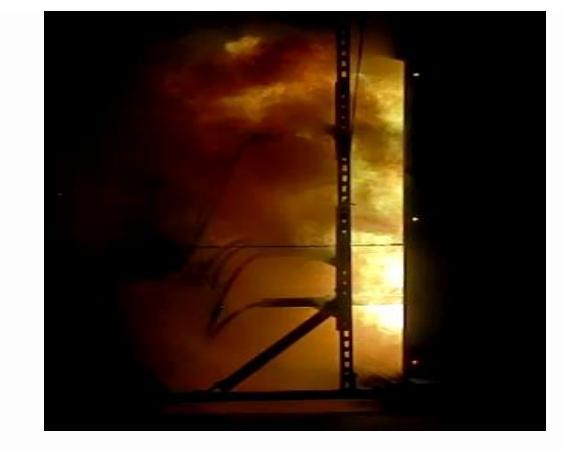
Fig 10: More energy from sides and bottom, test ID #48

Previous testing [4] concluded that if an obstacle (circuit breaker) was inside the switchgear, much of the incident energy would be diverted or absorbed by the obstacle. To verify this conclusion, a simulated breaker was constructed. As shown in Figure 10, the presence of the object forced most of the incident energy out the sides and bottom of the cubicle.

The presence of an object in the cubicle reduced the amount of energy ejected. However, the values generally exceeded the IEEE 1584-2002 predictions but with smaller multipliers. As shown in Table 2, the multipliers varied from 1.0 to 1.8. This appears to be a function of how far the simulated breaker was inserted into the cubicle. More energy is ejected with the breaker farther out of the cubicle. This confirms the conclusions with the laboratory arc-in-a-box mock up done during previous testing [4].

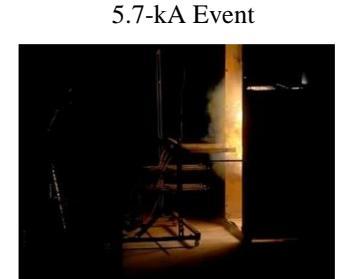
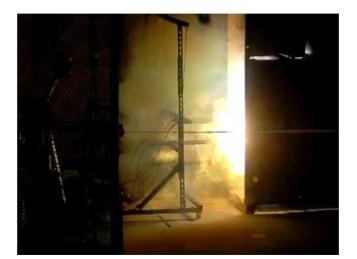
Fig. 11. Side-by-side comparison, 5.7 kA on left, 9.1 kA on right

Higher currents also eject energy faster than lower currents. For 5.7 kA, it took three cycles to reach 24 in (61 cm) and six cycles to reach 36 in (91 cm). However, for 9.1 kA, it took only one cycle to reach 24 in (61 cm) and only three cycles to reach 36 in (91 cm). See Figure 11 for a side-by-side comparison of Test ID #52 and Test ID #55. Figure 11 also

demonstrates higher overall energy. The end of the 9.1-kA event appears "brighter" than the end of the 5.7-kA event.

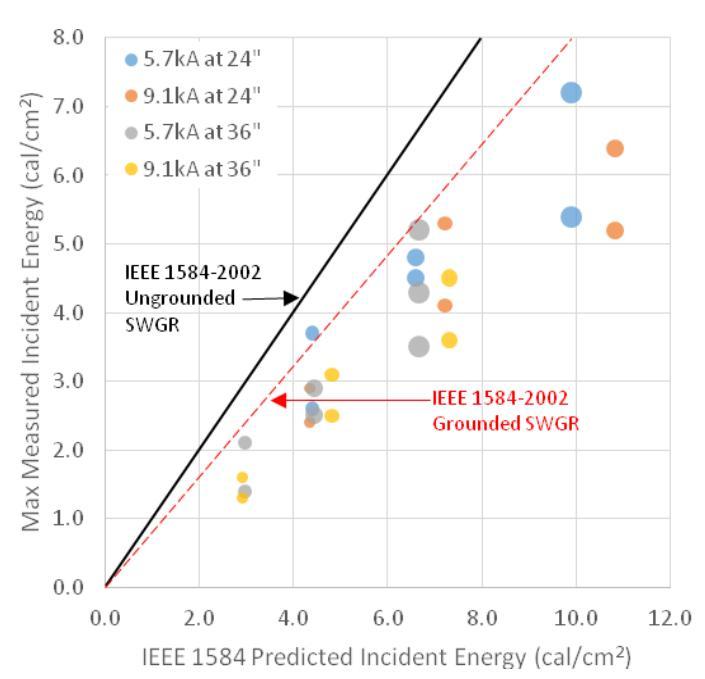
Fig. 12. Rack-up style switchgear: IEEE 1584-2002 predicted versus measured incident energy

Figure 12 shows that measured incident energies were below the predicted values of the IEEE 1584-2002 switchgear formula. The trend line is showing more conservatism as fault currents increase. However, additional testing would be needed to confirm this trend.

IEEE 1584-2002 has a 20% difference between grounded and ungrounded switchgear predictions. This is done from the original laboratory testing that suggested 20% of the energy returned via the ground connection and was not available for heat production. Figure 12 was overlaid with the IEEE 1584-2002 grounded switchgear predicted energy to show the relative difference between the ungrounded and grounded predictions. Even though this switchgear was tested with an ungrounded source, the IEEE 1584-2002 grounded prediction envelopes all but one measured value.

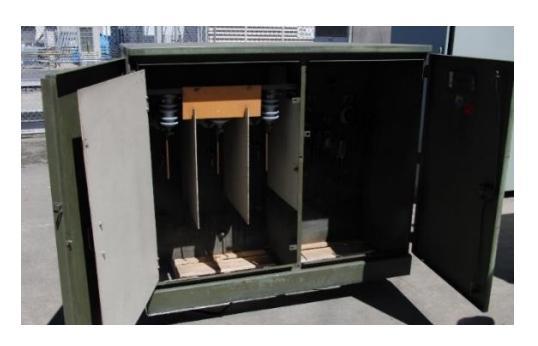
Fig. 13. Specimen #1: 3Φ 12kV-120/208V 75 kVA (small one) style IIA

The transformers tested are shown in Fig; 13 through 17 by the order they were tested.

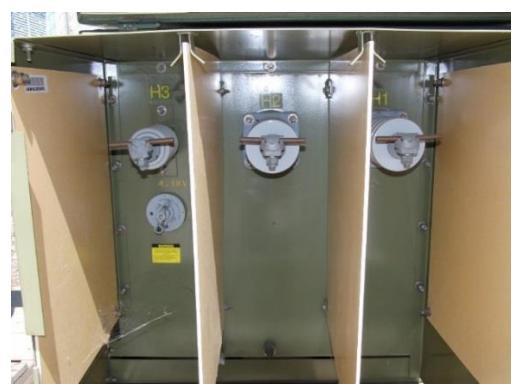
Fig. 14: Specimen #2: 1Φ 4160/7200 X 12000V-120/240V 50-kVA clamshell with 3Φ cabinet

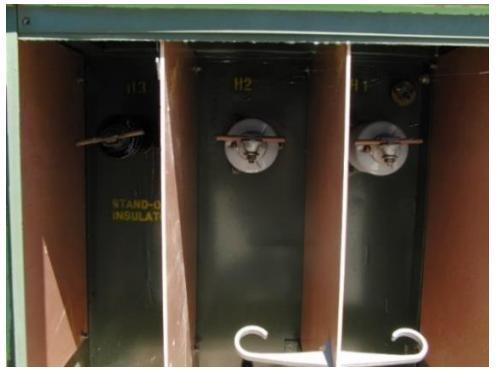
Fig. 15. Specimen #3: 1Φ 4160 X 12000V-120/240V 37.5kVA OLD style with 3Φ cabinet

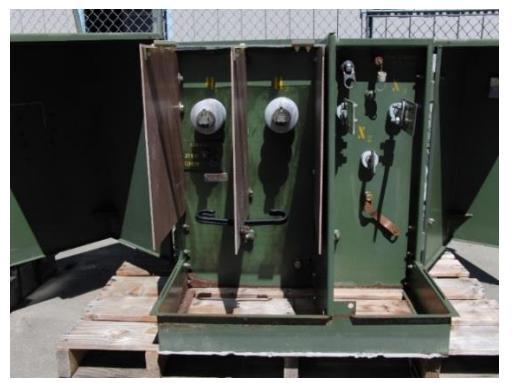
Fig. 16: Specimen #4: 1 Φ 12kV x 21kV-120/240V 50-kVA box style with 1 Φ cabinet

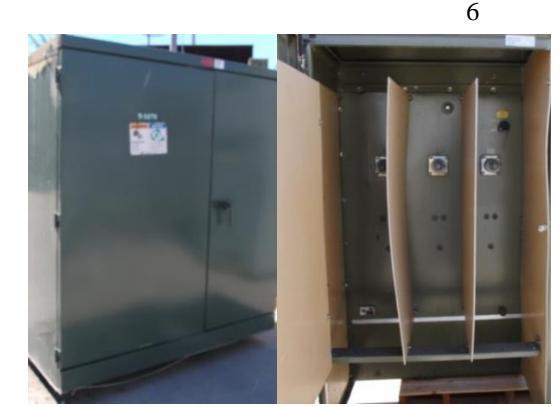
Fig. 17: Specimen #5: 3 Φ 12kV x 21kV-277/480V 750kVA (large one) radial style

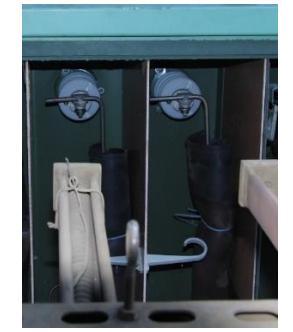
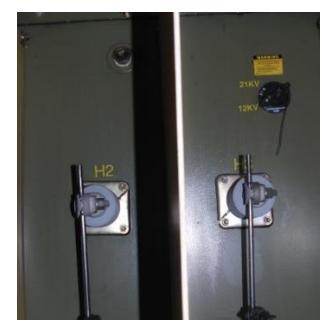
Fig. 18: Horizontal (left) specimen #3 vs vertical (right) specimen #5 pin terminals

Specimens #1 and #5 had pin terminals that pointed vertically while the others had pin terminals facing horizontally. The pins were bent at a right angle to left to fit into the horizontal terminal. See Figure 18.

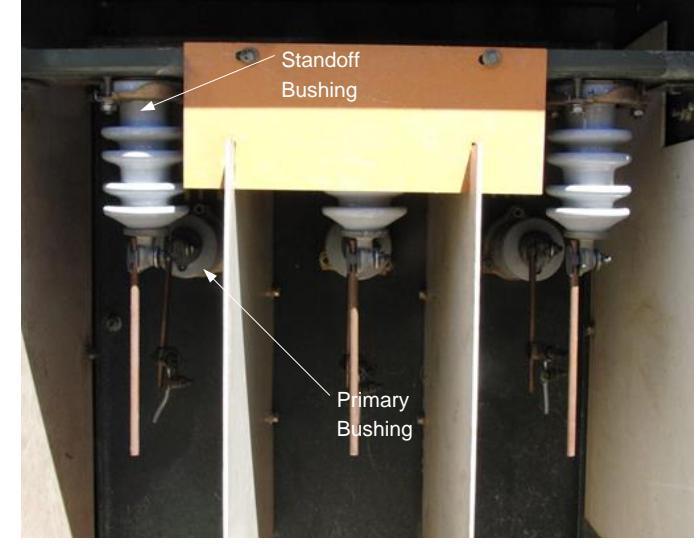
Fig. 19: Specimen #1 primary bushing compartment: showing standoff bushing in front of primary bushing

Specimen #1 had a set of standoff bushings installed from the top down in front of the primary bushings coming out of the transformer on the back wall. These were left in place to see if they had a deflecting influence on the heat. See Figure 19.

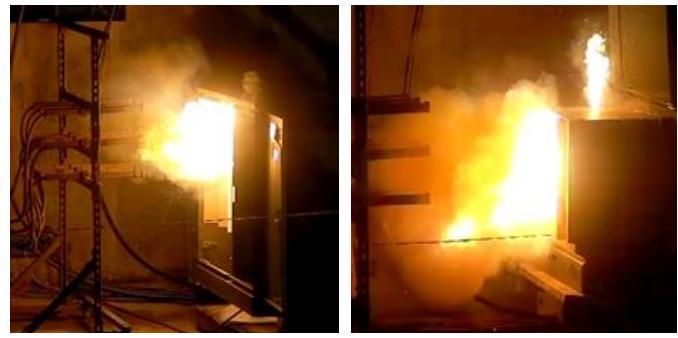
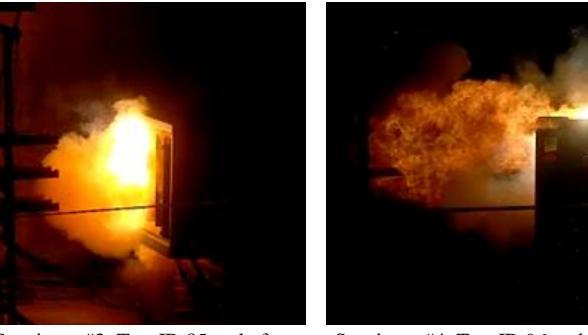
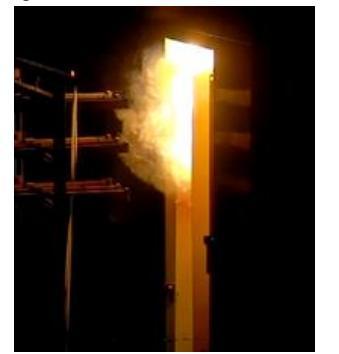
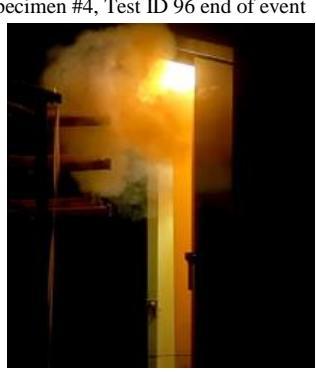
Specimen #1: Test ID 64 end of event Specimen #2: Test ID 74 End of event

Specimen #3: Test ID 85 end of event Specimen #4, Test ID 96 end of event

Specimen #5: Test ID 106 mid-event Specimen #5: Test ID 106 end of event Fig 20: Comparison of energy pattern from each specimen

Most specimens propagated to multiphase arcs on their own very early in the test, except for the smallest and the largest enclosures, specimen #4 and specimen #5. These did not propagate to multi-phase until the bushings were very contaminated and beginning to erode. However, even with single-phase arcing, these two expelled more incident energy than any of the other specimens even when they went three phase. The fireball ejected from the cubicle was not only different in magnitude but also direction. Every specimen had a first test of 2.3 kA for 20 cycles. Figure 20 shows the comparison of incident energy patterns (fireball) for each specimen.

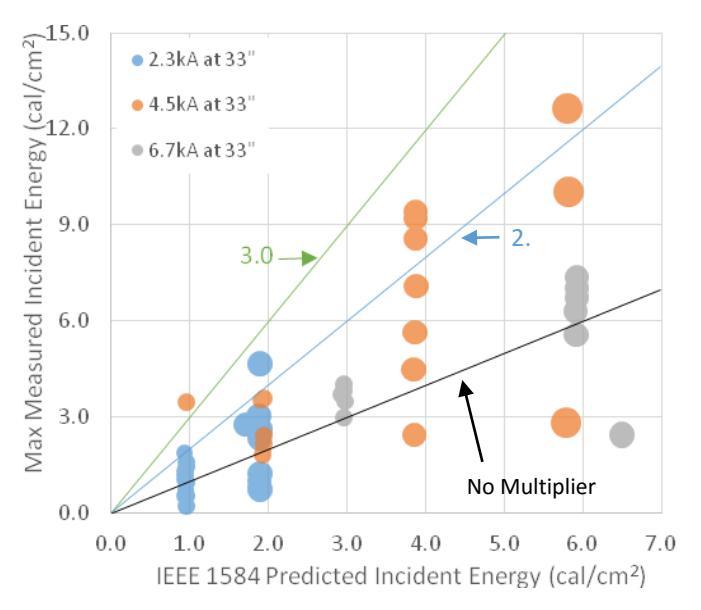
Note 1: Bubble size reflects arc durations 20, 40, 60 cycles respectively. Lines represent multipliers to IEEE 1584-2002.

Fig 21: Live-front transformers: IEEE 1584-2002 prediction vs measured incident energy

Recommendations in previous EPRI reports [4, 5] were to use IEEE 1584 for all arc-in-a-box scenarios for voltages from 1 to 35 kV. For 25- and 35-kV class equipment, enter a voltage of 10 kV in the IEEE 1584 spreadsheet, so the Lee Method is not triggered (the Lee Method gives incident energies that are unrealistically high). The measured values exceed predicted values using the IEEE 1584-2002 formula, as shown in Figure 21. See Table 4 for the overall probability that each multiplier to IEEE 1584-2002 encompasses all the test data points.

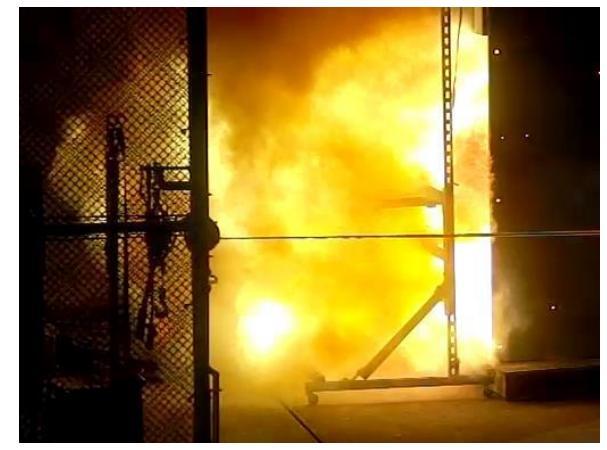
Fig 22: Horizontal racking configuration: 22.1 cal/cm²

Rack-in switchgear with horizontal electrodes had much higher incident energies than the switchgear with vertical electrodes. With horizontal electrodes, the magnetic forces push the arc and the fireball out the front of the enclosure. With horizontal electrodes, the fireball goes downward, and more energy stays in the enclosure. Figure 22 and Figure 23 compare similar events on the two types of switchgear tested. Both events were done with $I_{arc} = 8.4$ kA and duration = 31 cycles. IEEE 1584-2002 predicts 6.9 cal/cm² for these conditions.

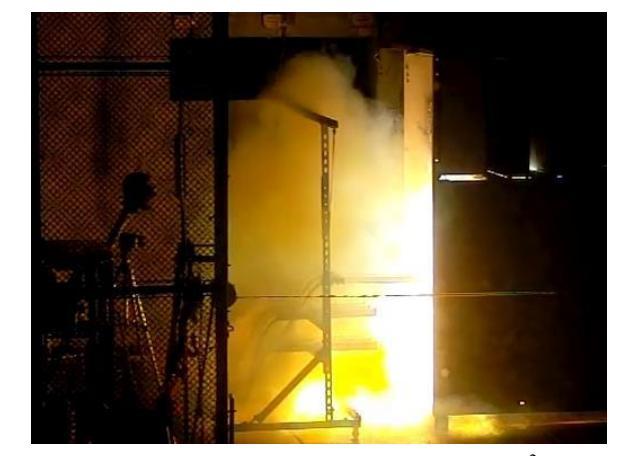
Fig 23: Vertical racking configuration: 6.4 cal/cm²
